STAFF REPORT

Meeting Date: November 15, 2016
To: Honorable Mayor & City Council
From: Aaron Kunz, Deputy Director of Transportation
Subject: Consideration of Fehr & Peers Evaluation of Crosswalk Treatments
Attachments: 1. Beverly Gardens Park Renderings
2. Fehr & Peers Memorandum – Pedestrian Crossing Evaluation

MEMORANDUM

Subject: Pedestrian Crossing Evaluation

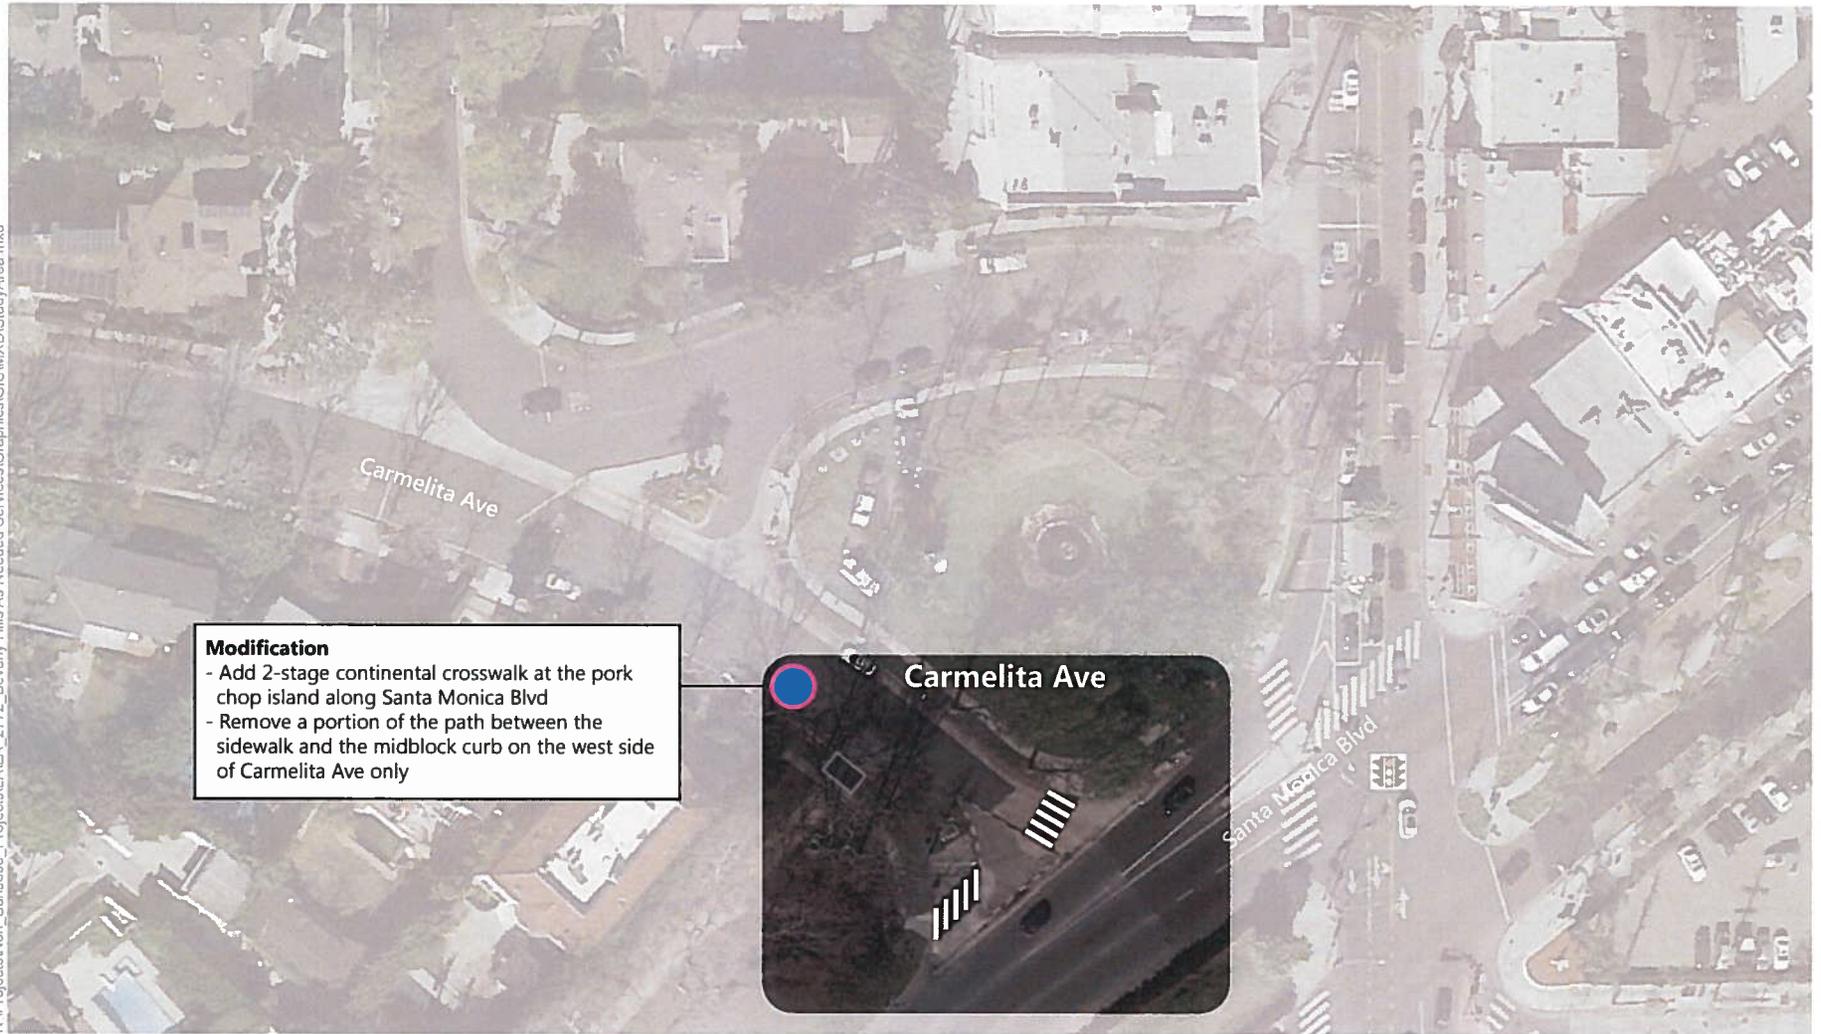
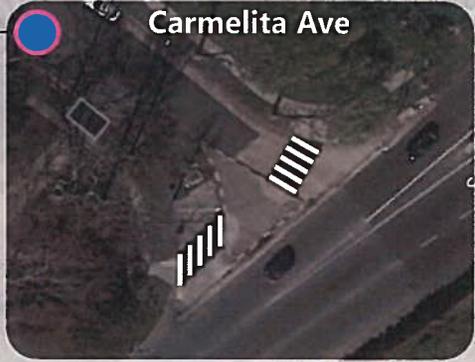
One other exception to the standard best practice options is at the intersection with the pork chop island at Carmelita Avenue and Santa Monica Boulevard (Figure 8). At this location, the proposed treatment is a two-stage continental crosswalk along Santa Monica Boulevard. This will provide high visibility crosswalks with an existing refuge island. Given that the crosswalks are not set back from the intersection and there is an existing median refuge island, consideration of raised crosswalks is not recommended. In addition, the fluorescent yellow-green signage is not included as a recommendation since the southbound approach is stop controlled and the crossings are located at an intersection, which is an expected location for motorists to encounter pedestrians.

Modification
 - Add 2-stage continental crosswalk at the pork chop island along Santa Monica Blvd
 - Remove a portion of the path between the sidewalk and the midblock curb on the west side of Carmelita Ave only

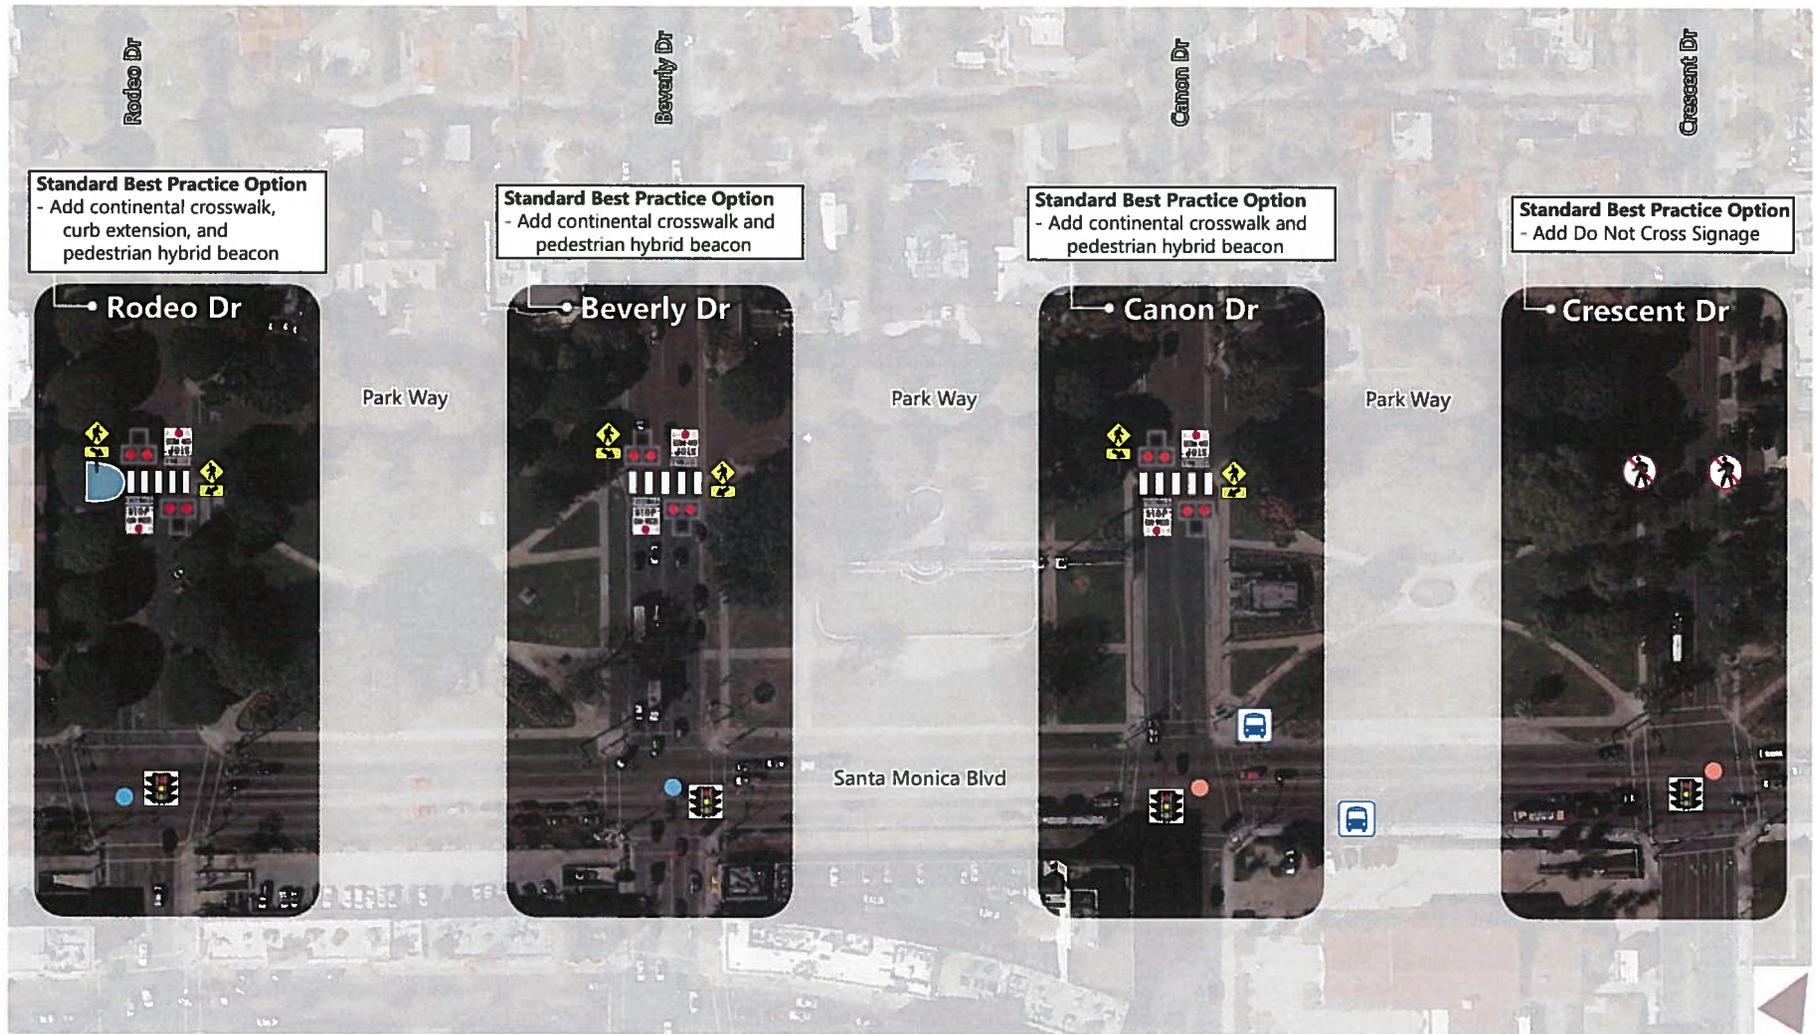
Due to the lower volumes observed on Crescent Drive (22 during the peak hour) as well as its location at the terminus of Beverly Gardens Park with no path continuation on the east side, crossing prohibition signage could instead be considered to direct pedestrians to the signalized crossing at Santa Monica Boulevard.

All of the best practice options along Park Way are illustrated on Figure 9.

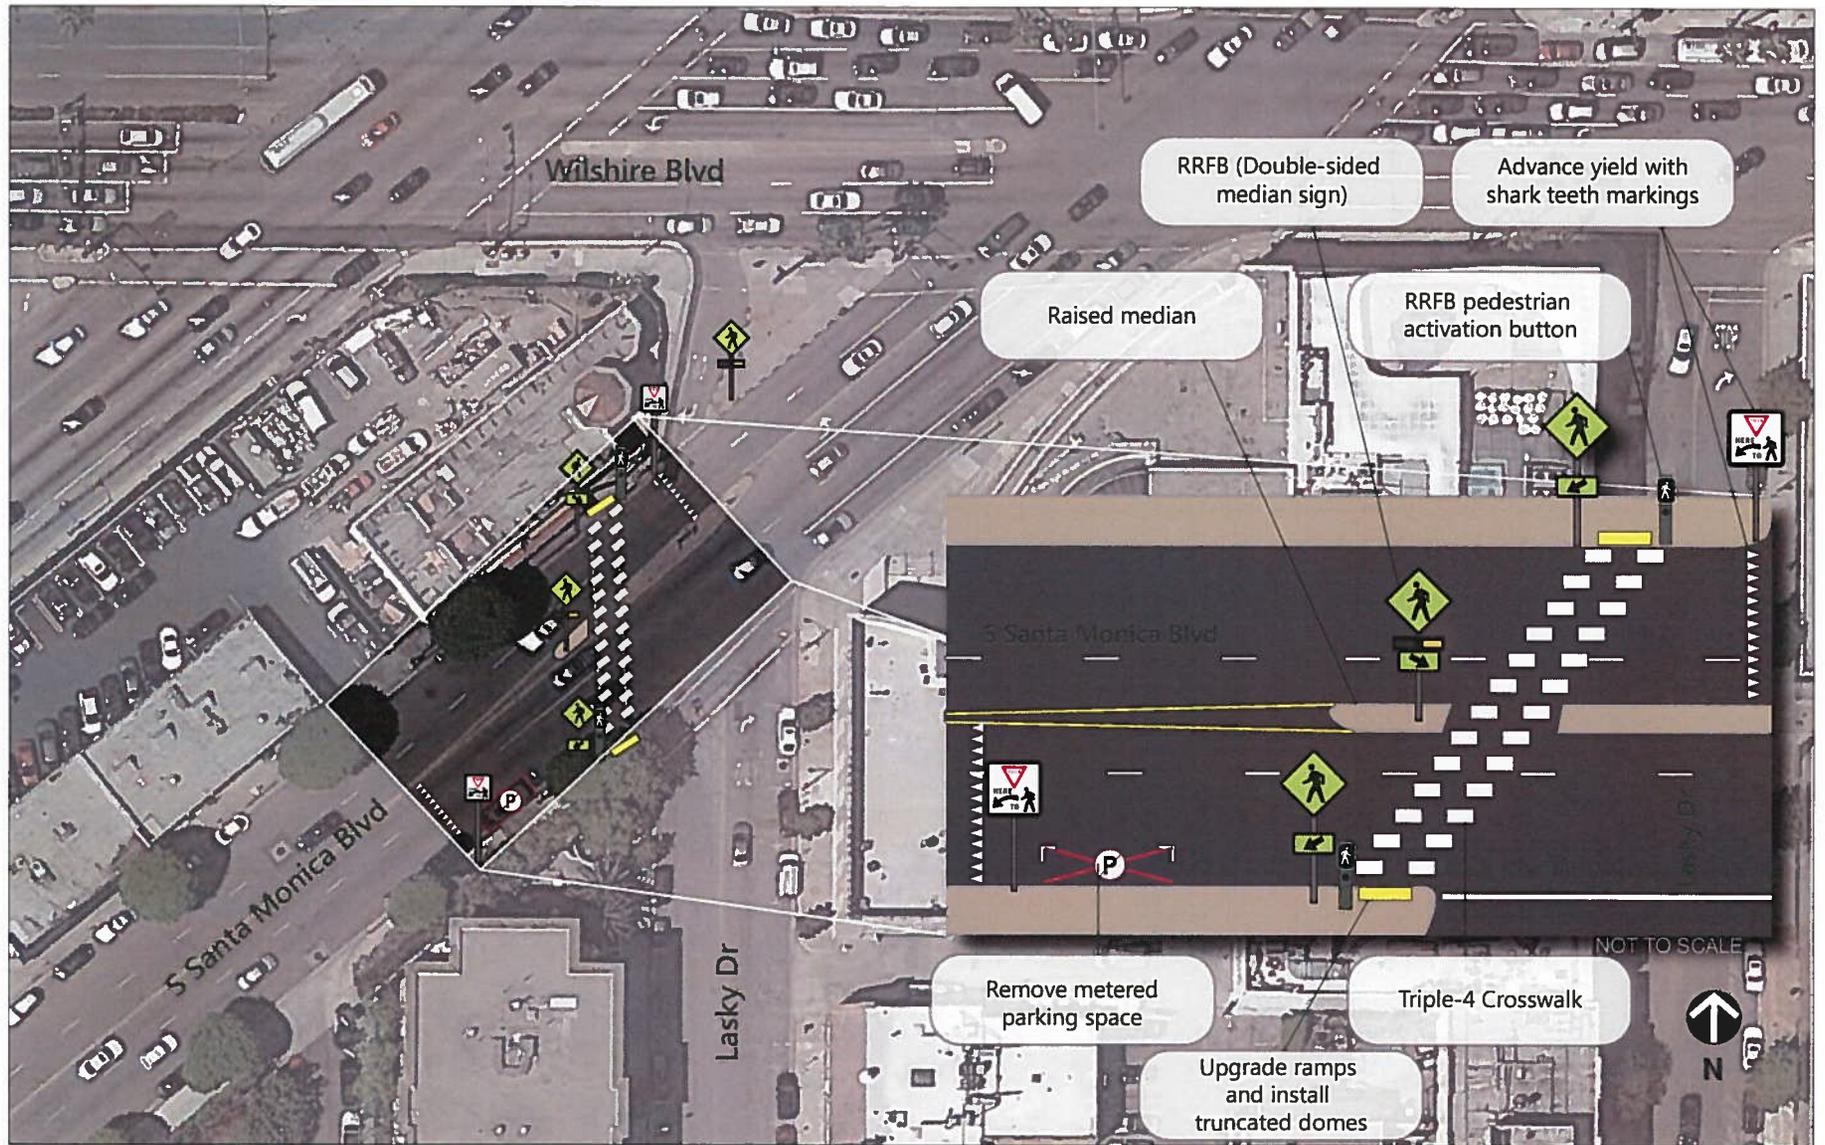
Currently, there are roadside pedestrian crosswalk warning signs for both approaches. The signage for the westbound approach includes a W54(CA) (pedestrian symbol with crosswalk lines) with a "PED XING" plaque located beneath on a street light immediately before the crosswalk. The larger sign is bent and leaning

because it extends beyond the sidewalk into the roadway and is likely hit by larger vehicles turning right from the access lane from Santa Monica Boulevard. The same two signs are in place for the eastbound approach on a street light located about 20 feet before the crosswalk. This combination of signs has been deleted from the California Manual on Uniform Traffic Control Devices and replaced with the W11-2 (pedestrian symbol without crosswalk lines) and W16-7P (downward pointing arrow). The existing signs could therefore be replaced and upgraded to fluorescent yellow-green for greater conspicuity.

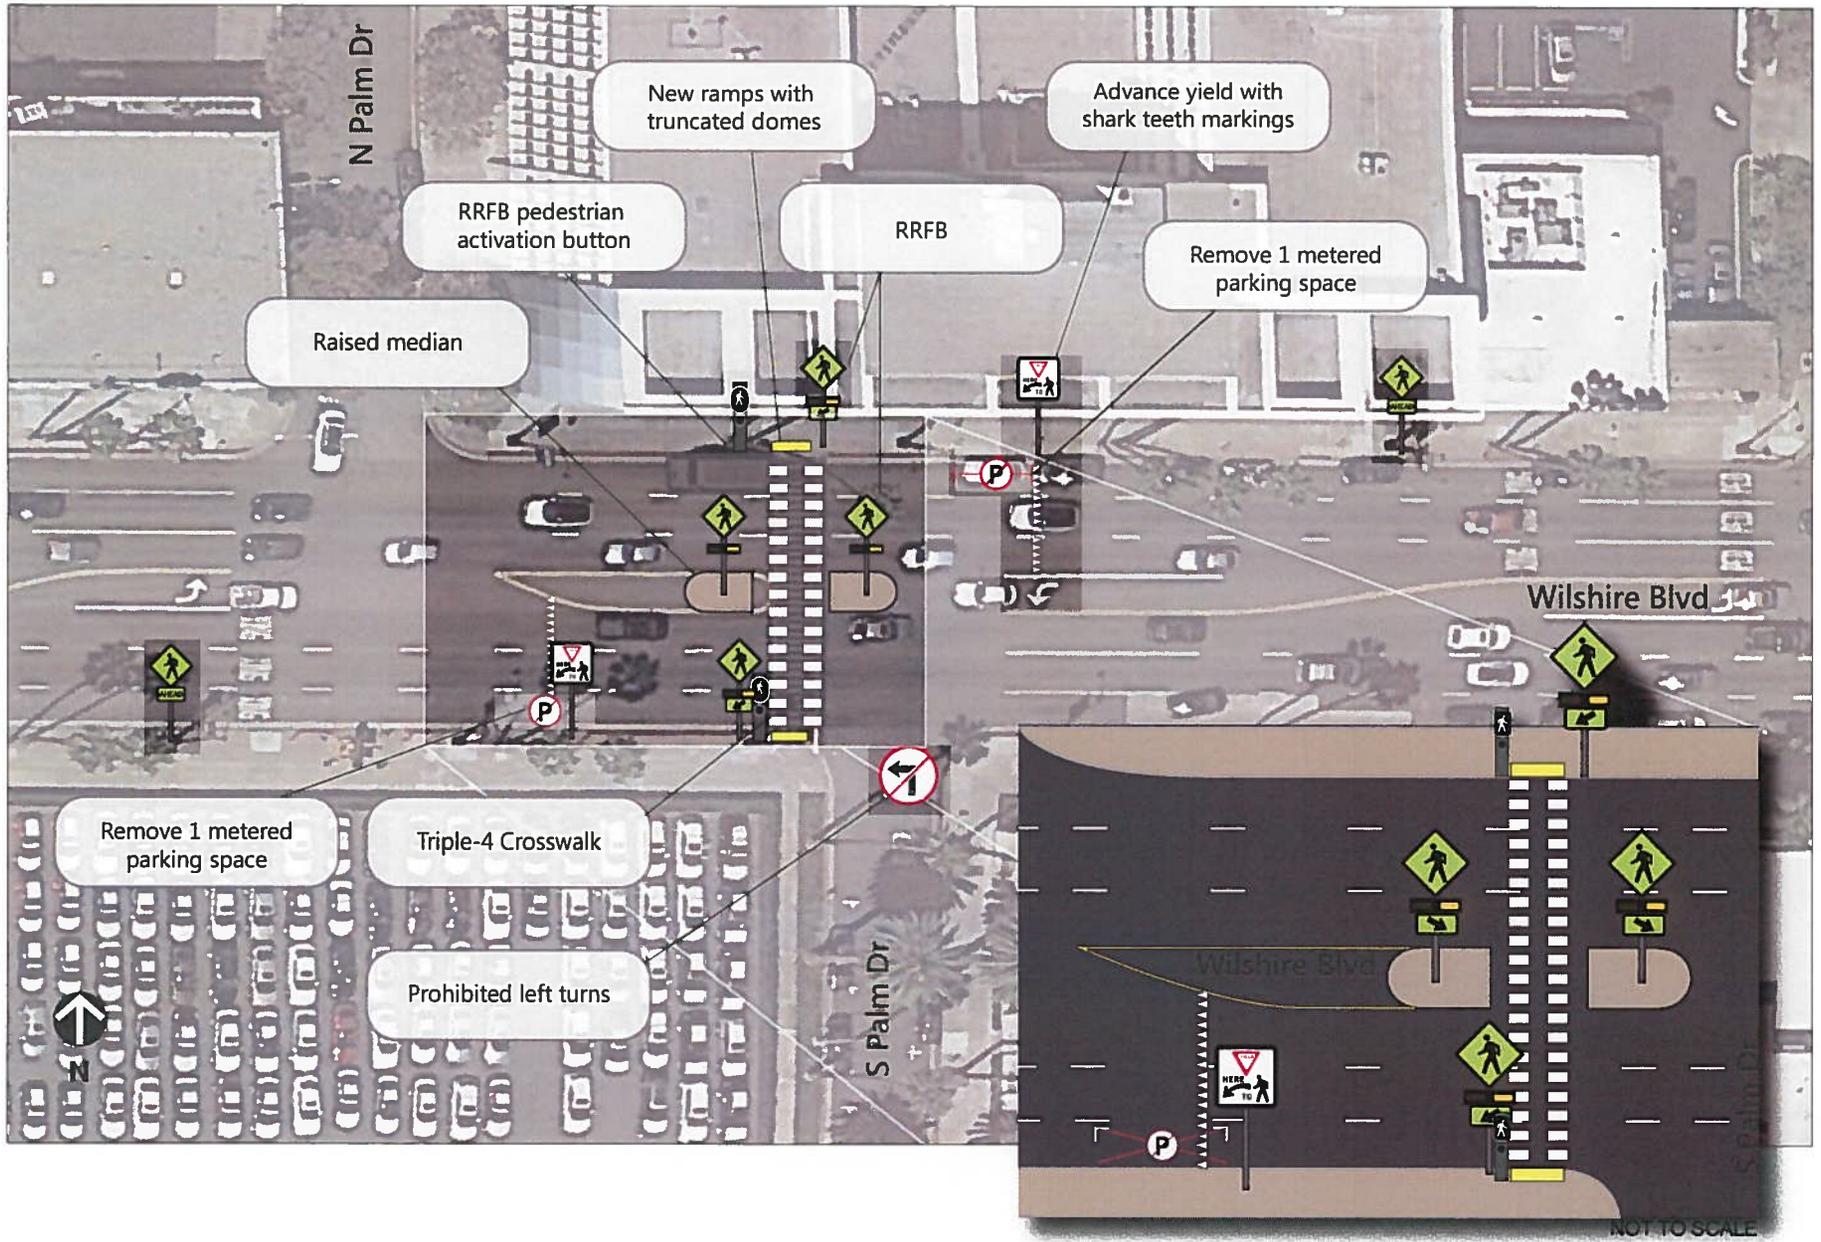
Currently, there are roadside pedestrian crosswalk warning signs for both approaches. The signage for the westbound approach includes a W54(CA) (pedestrian symbol with crosswalk lines) with a W16-7P (downward pointing arrow) beneath located on a street light before the crosswalk. To bring it to current standards, the top sign could be replaced with the W11-2 (pedestrian symbol without crosswalk lines). Also, both signs could be upgraded to fluorescent yellow-green for added conspicuity. There are also two advance warning signs, a W54(CA) with a "PED XING" plaque. Similarly, these could be replaced with W11-2 signs and an "AHEAD" plaque (W16-9P). The same upgrades could be implemented for the eastbound direction.

The multi-lane configuration creates the potential for multiple-threat crashes. This condition can be improved with the installation of advanced yield lines. If installed, it is recommended that they be placed the maximum 50 feet in advance of the crosswalk on both approaches, along with "Yield Here" signage. This would require the removal of a single metered parking space on both the eastbound and westbound approaches.

To alert motorists to the presence of pedestrians, a rectangular rapid flashing beacon system could be installed. If installed, four beacons are recommended at the following locations: on the north side of the road facing westbound traffic, two on new raised medians facing both directions of traffic, and one on the south side of the road facing eastbound traffic. If this option is selected, pedestrian-activated push buttons are recommended.

Modifications at this crosswalk should be accompanied by Americans with Disabilities Act upgrades, including curb ramp reconstruction to satisfy slope and clear space requirements, as well as 36-inch strips of detectable warnings at the bottom of the curb ramps.

A left-turn restriction from northbound South Palm Drive onto westbound Wilshire Boulevard could be analyzed and considered for implementation. These left turning vehicles must cross three travel lanes in order to complete the movement. Considering the heavy traffic volumes on Wilshire Boulevard, many drivers trying to make left turns may need to react and accelerate quickly to take advantage of small gaps in both directions of traffic. Drivers in this situation may not notice a pedestrian in the crosswalk, leading to potential conflicts. A left-turn restriction would remove this potential conflict.
