C. Physical Description of Existing Conditions

C1. Exterior Conditions

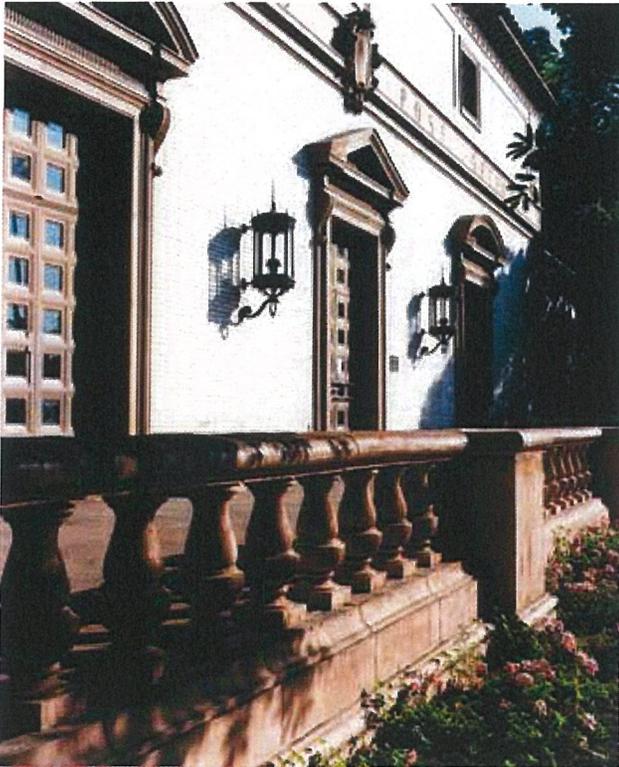
North Elevation & Terrace - 2002

The north façade of the building, which faces Santa Monica Boulevard, is the most formal of the four elevations and the most symmetrical. Faced in brick veneer and terra cotta, the north façade appears to be the main entrance to the building even though it is not. Three sets of ornate bronze double doors with terra cotta surrounds and architraves act as the focal point of the elevation with the center door, the only one that originally operated, distinguished by a different architrave than the other two. Ornate bronze lanterns which are still operable flank the center door. The doors are accessed off of a stone terrace with a terra cotta balustrade which has been repaired in the past but is still in need of work.

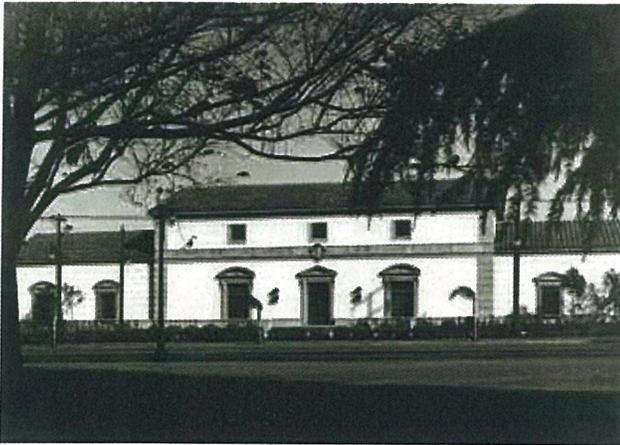
North Elevation

Above the doors a band of terra cotta runs the entire length of the two-story portion of the building and is incised with "UNITED STATES POST OFFICE" in large letters. In the center of the terra cotta band, a large terra cotta cartouche draws attention to the center of the building, directly above the sole operating door on this elevation.

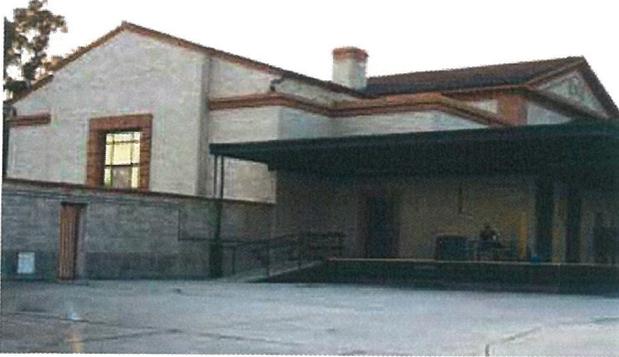
South Elevation - Loading Dock

The south façade of the building, facing Burton Way, has many more distinct elements due to the ins and outs of the floor plan. The elevation is partially obscured by a wall surrounding the service yard but the numerous windows types are plainly visible. All of the windows have been coated with a mirrored film to prevent visibility into the non-public working spaces of the building. A small balcony with a wrought iron railing is located off the second floor which adds a sense of scale to the elevation.

The boiler flue also protrudes from the roof on the south side of the building, well disguised as a chimney.

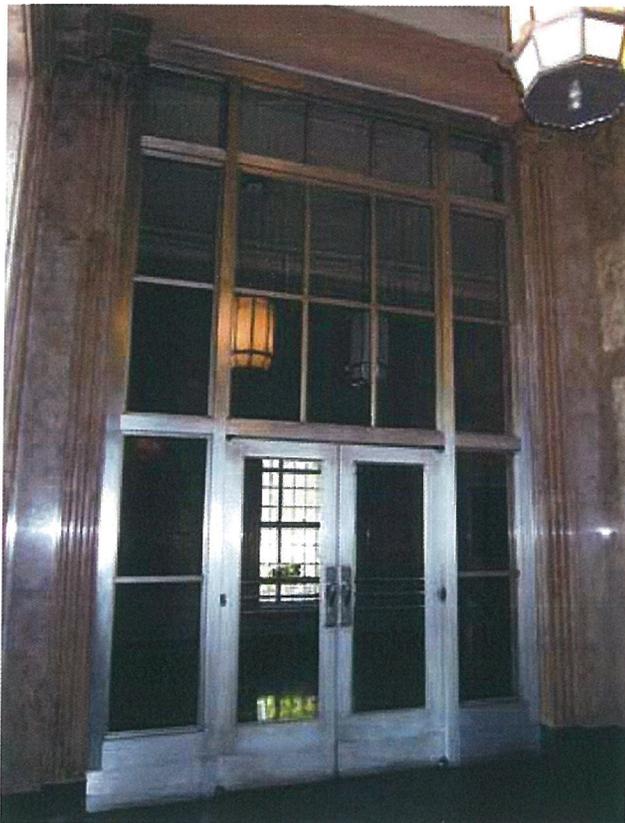
West Foyer - North Wall with Added Door & Partition

The main entry door in the west wall was replaced in 1950 with aluminum frame doors and in 1961, metal lovers were added on the exterior in the vestibule surrounding the door for air intake. The north wall of the room is taken up by an aluminum and glass partition with a set of double doors that was added in 1961.

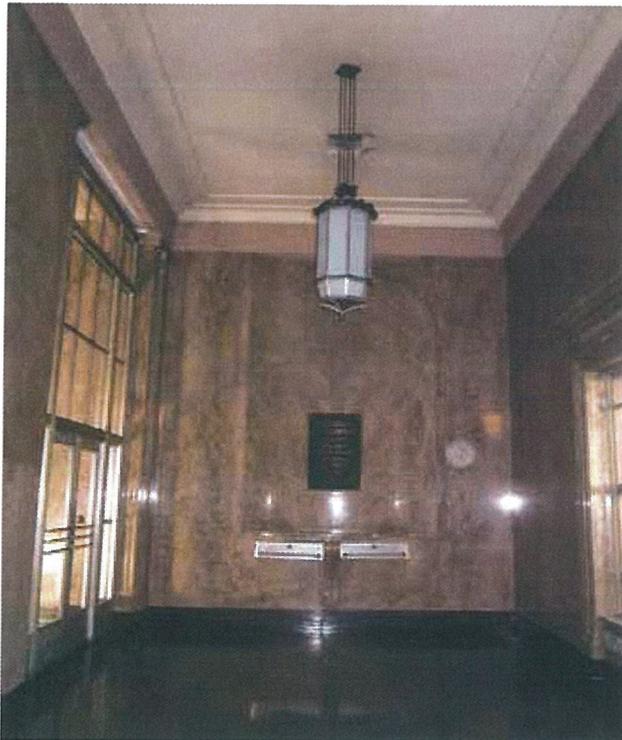
West Lobby - 2002

The west wall houses one of two original bronze plaques set in a curved recess that lists the original contributors to the building. The large metal windows in the north wall are surrounded by ornately carved marble trim and topped by a carved marble architrave with radiator recesses concealed in the wall directly below the windows. The south wall originally contained two teller windows, slightly recessed in a surround of fluted marble with marble deal plates for transactions. Aluminum grilles covered the transaction windows and decorative metal lights were located on the wall directly above the teller windows. The teller windows, fluted marble surround panels, marble deal plates and wall-mounted lights were removed in the 1961 remodel for the addition of post office boxes. Those boxes were removed when the post office was decommissioned and today a large opening in the wall is all that remains.

Two historic artifacts also remain in place, the original aluminum bulletin boards and the aluminum lobby desks that were design specifically for the space.

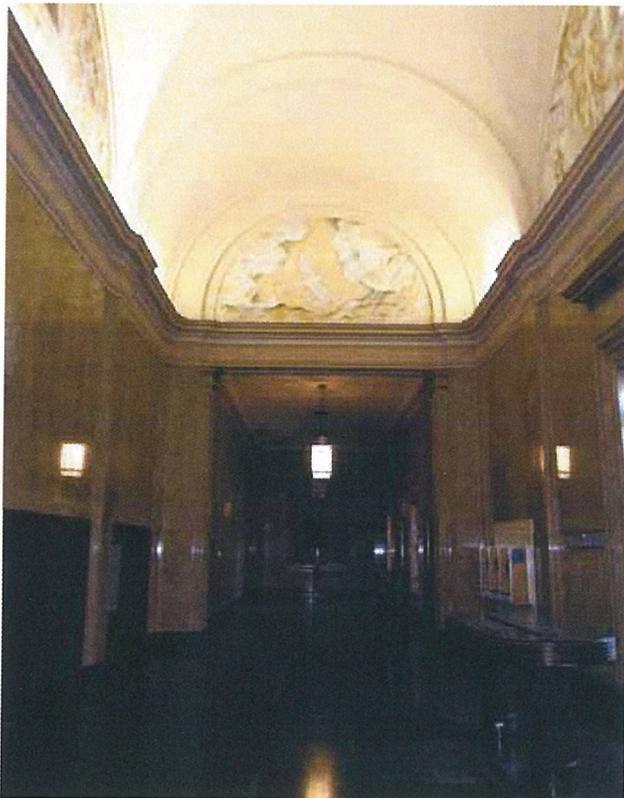
Main Lobby - 2002

The main lobby has the same level of finish as the east and west lobbies but on a grander scale due to the double height space and barrel vaulted ceiling. Roseal marble covers the north and south walls and the marble floor continues through the space, once again changing pattern to fields of verde green surrounded by a wide border of French gray.

The marble on the walls remains at a constant height, matching the marble in the east and west lobbies while the space above, created by the change to a two story space, is occupied by plaster coves in which a layer of canvas was applied and artist Charles Kassler painted his murals. The north and south walls contain the mural titled "Construction - PWA" in six panels, three on the north wall and three on the south wall. The west wall contains the mural "Air Mail" while the east wall houses "Post Rider". The marble below the murals had many distinct features on the south and north walls, some of which still remains in place. The north wall has six fluted marble radiator enclosures as well as ornate marble surrounds and architraves at the doors. A different inscription is carved into each marble architrave above the three doors which, from west to east, read "Commitment", "Cooperation", and "Enlightenment".

groupings of post office boxes all located in fluted marble surrounds. Above each of the post office box groups is located a decorative circular element, on the two outer banks it was a carved marble plaque and above the center bank it was a decorative metal clock. Increased patronage by the 1960s resulted in a need for additional post office boxes and in the 1961 remodels the teller windows and original boxes were removed to allow for installation of more modern post offices boxes. In the two bays to the west post office box alcoves were built, extending into the workroom space behind. New brick tile floors were laid in the alcoves and dropped ceilings were added. When the post office was decommissioned, the boxes were removed and today the alcoves remain as shells with clear views through the openings that once housed the P.O. boxes into the empty workroom beyond. Windows located in the south wall at mural level that once provided views from the second floor into the lobby have been blocked off to allow for the supply of air into the room through ductwork that was also added in the 1961 remodel.

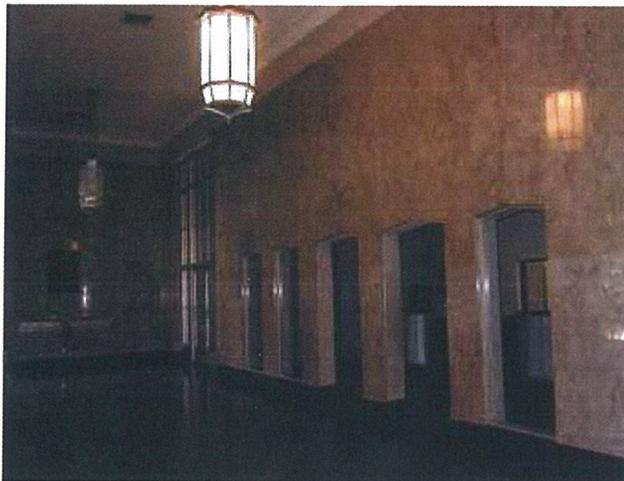
East Lobby - 2002

The east lobby is a mirror image of the west lobby with the exception of the south wall. The wall, which originally contained 5 teller windows unlike the west lobby which only contained 2 teller windows, was modified in 1961 to allow for expansion of retail sales. The fluted marble recesses that once housed the teller windows were cut out to allow for access into a new room that was created behind the wall in the workroom space. This new room will be discussed in section "1g. - Workroom".

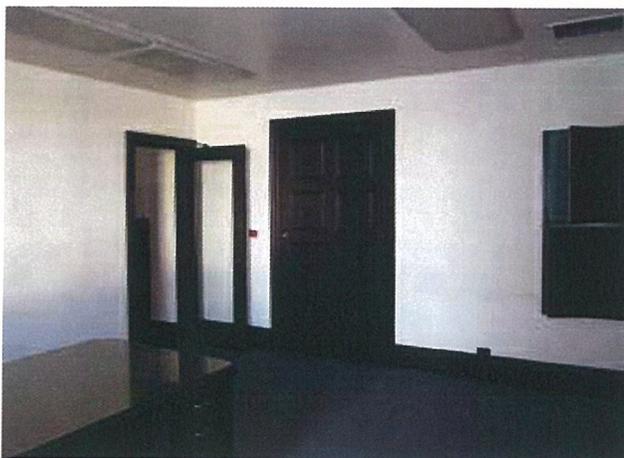
Superintendent of Mails Office - 2002

The Superintendent of Mails office has been modified over the life of the building resulting in a room that retains only some of its original stature. The original wood block floor has been covered with carpet although the wood base is still intact, and a lowered gypsum board ceiling was added in 1961 along with flush mounted 2'x4' florescent lights. The lowered ceiling partially obscures the steel window. The original metal doors and trim are still in place.

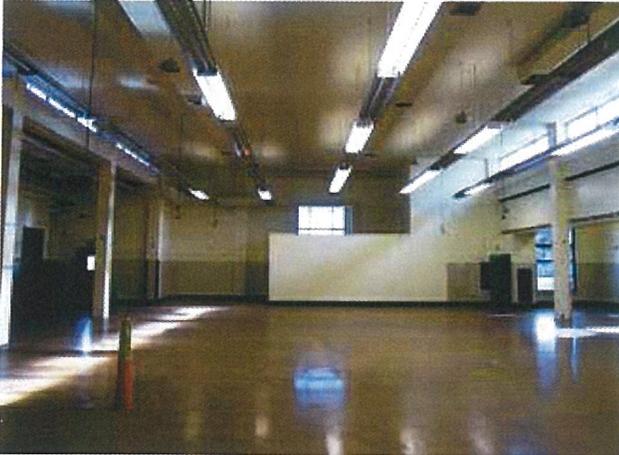
Workroom with Women's Lounge at End - South Elevation

Today the volume of the workroom remains much as it did in 1934 but numerous items have been added or changed over the years. The wood block floor has been covered by a vinyl sheet floor that resembles wood parquet flooring. Four new rooms or elements have been added in the space including a retail service center off of the east lobby, a women's lounge at the south end of the room and two P.O. box alcoves off of the main lobby. The floor of the retail service center and the P.O. box alcoves were covered in masonry tile while the floor of the women's lounge was covered in vinyl. Dropped gypsum board ceilings were constructed in all four spaces, interrupting the continuity and height of the room.

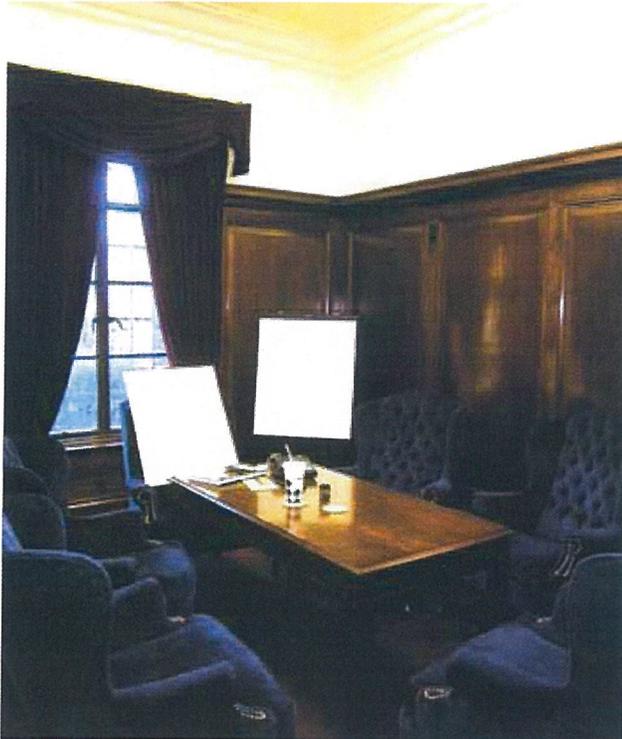
Postmaster's Office - 2002

The Postmaster's Suite contained five rooms: the postmaster's office, secretary/reception, assistant postmaster's office, private toilet and a safe. Specified with a higher level of finish than the rest of the non-public spaces, the suite was finished with American walnut trim instead of metal including wood window surrounds. The ceilings are suspended plaster with plaster cove transitions from wall to ceiling. The walls separating the secretarial area from the two offices contained pivoting wood windows which remain on the east wall. The windows were removed on the west wall and replaced with a fixed pane of translucent glass. The walls of the postmaster's office are covered in 8' American walnut wainscot.

The original wood block floor in the offices and terrazzo floor in the toilet have been covered with red carpet and red velour curtains were added to the windows in the 1980s. All of the wood in the office suite was refinished during this time period as well. The safe that was once accessed through the postmaster's suite was reconfigured and the opening filled in. The safe door is now off of the workroom.

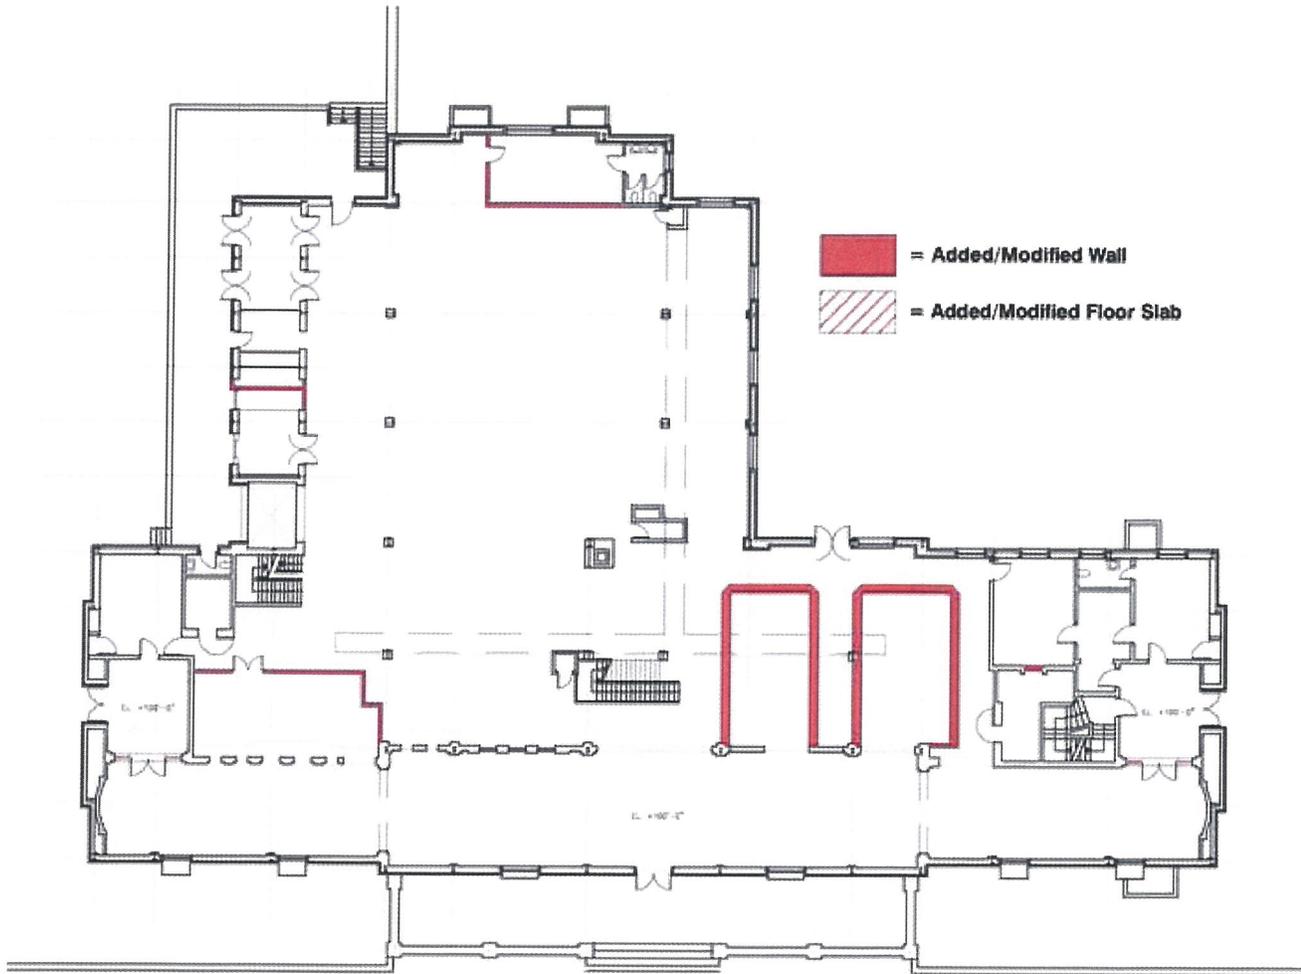
Modifications - First Floor

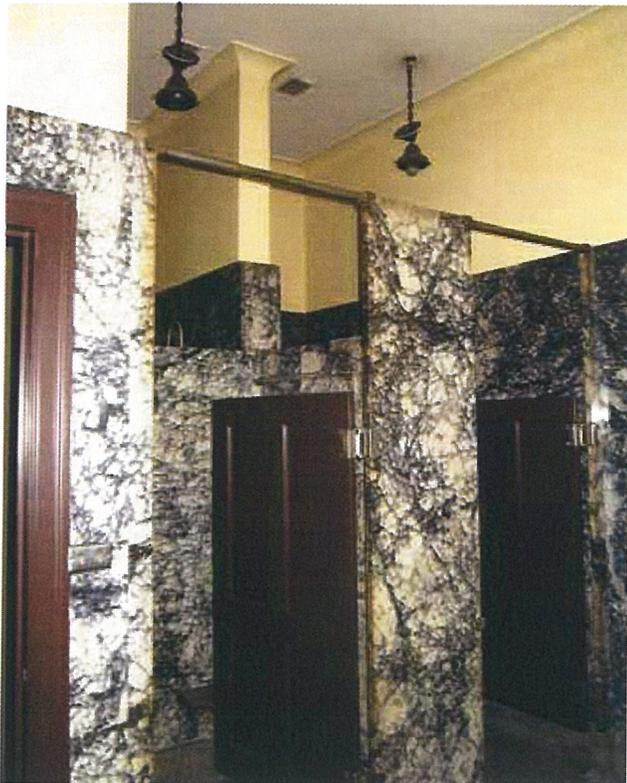
Men's Toilet Room Shower Area

The walls above the marble wainscot are plaster coated concrete and transition via a sanitary cove to the plaster ceiling above. The shower area and janitor's closet in the room have three original light fixtures, the only ones in the building aside from those found in the public lobby spaces. Only two of the fixtures have globes which have been removed and placed in the janitor's closet.

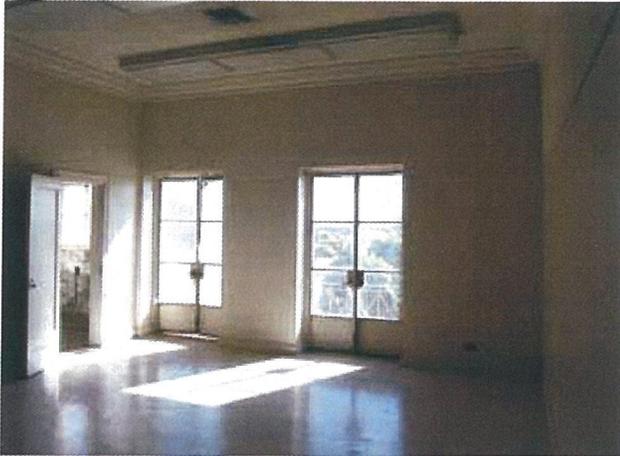
Postoffice Inspector's Office - 2002

The Postoffice Inspector's Office originally had a wood block floor that has been covered with sheet vinyl. The walls are plaster-covered concrete which beginning at 8' above the finished floor have been covered with direct glue acoustic tile that transitions onto the suspended plaster ceiling. The private toilet off of the office is finished in the same marble as the men's toilet off of the swing room with a terrazzo floor.

The windows and doors in the office are all original and the two windows are actually double doors that lead onto a small balcony with wrought iron railing. The doors need to be repaired, as they currently do not close due to corrosion.

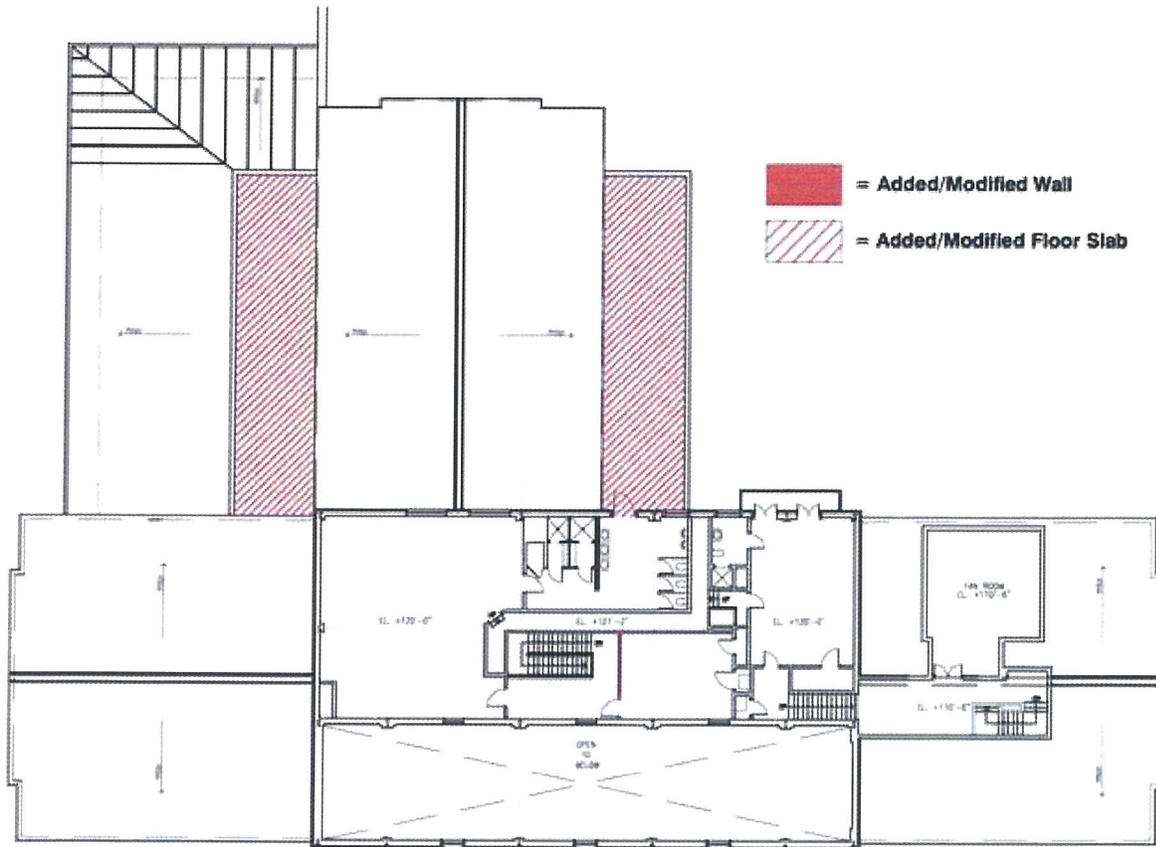
Modifications - Second Floor

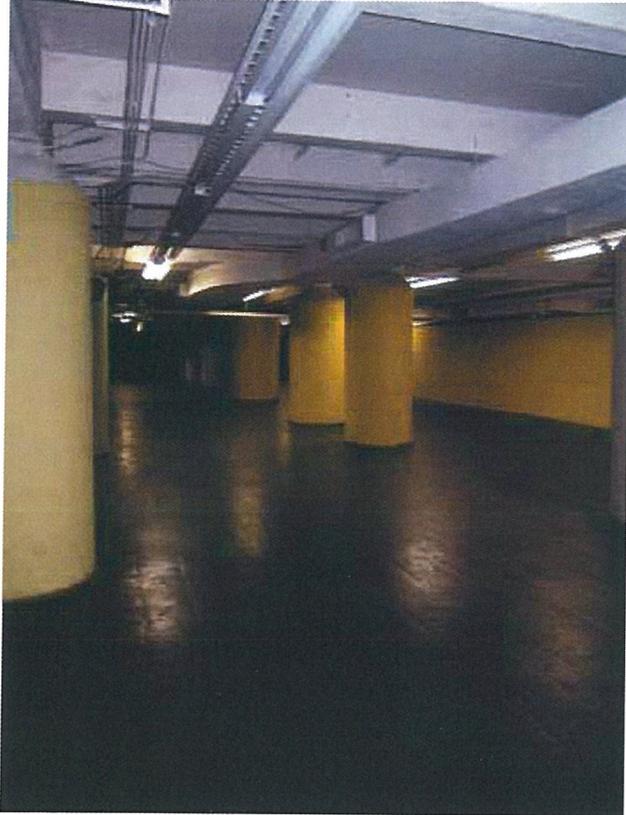
Basement Expansion

In 1961, the crawl space under the remainder of the building was excavated and the available space in the basement tripled. An exterior stair was modified to allow for the expansion and areaways were added to get air to the equipment placed in new mechanical rooms. The original caissons, which range from 35'-42' deep were partially exposed and stand freely in the space. A viewing corridor was added on this level, as were additional mechanical rooms, toilet rooms and storage areas. Overall the basement has little or no historic value.

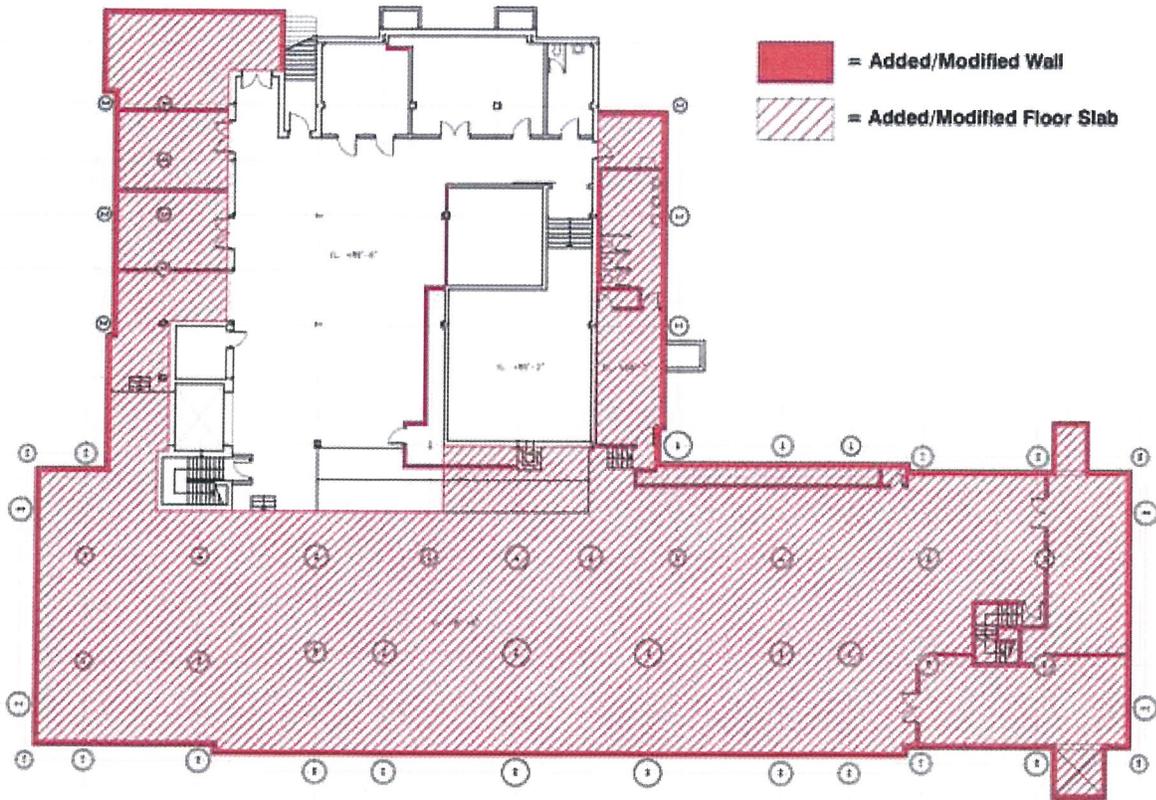
Modifications - Basement

The basement has been drastically modified and enlarged since it was originally constructed. Originally used for storage, mechanical and custodial purposes the floors, walls and ceilings are all concrete, some of which have integral color or have been painted. None of the original rooms in the basement remain with the exception of the boiler room which was depressed an additional two feet from the rest of the original basement.
