**STAFF REPORT
CITY OF BEVERLY HILLS**

**For the Architectural Commission
Meeting of June 16, 2010**

**SUBJECT: BEVERLY HILLS PORSCHE
8423 Wilshire Boulevard**
Request to install a freestanding screen element in front of the Wilshire Boulevard façade of a commercial building listed on the City's Historic Resources.
(PL 101 3722)

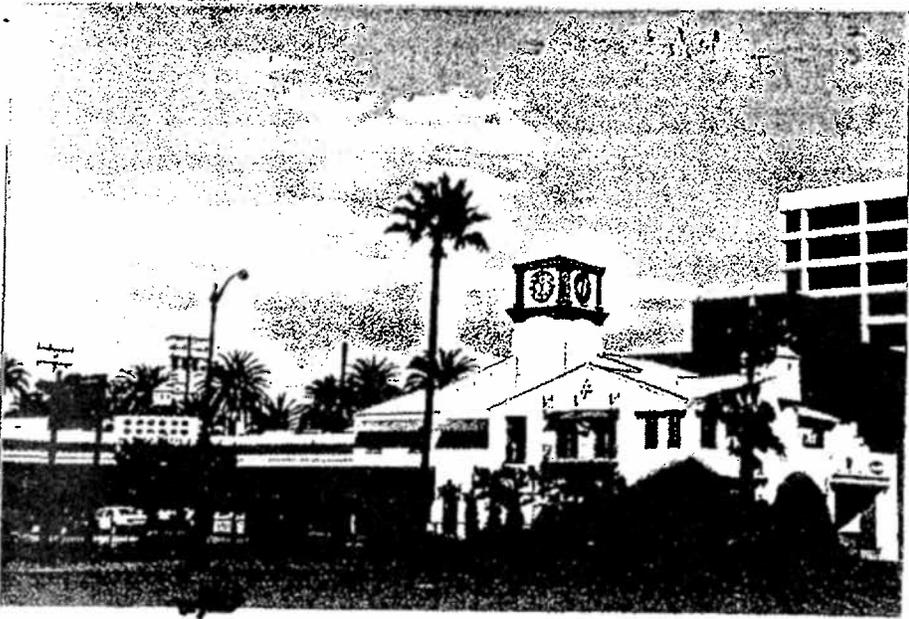
The Clock Market is an outstanding example of a commercial building type developed in the 1920s in response to the new automobile-oriented lifestyle. It is a one and two story L-shaped building, situated on the northeast corner of Wilshire Boulevard and Hamilton Drive. Of stone tile construction, it is sheathed in stucco and its gabled roof covered with clay tile as was appropriate for the Spanish style. The two story portion of the structure, at the south end of the east wing, is dominated by the square clock tower that gave the building its name. Typical Spanish characteristics are displayed, including arched entries on the south and west, balconies of stucco and iron, casement windows separated by pilasters, clay tile roof vents, and iron grilles. Other distinctive features are a smaller, corbelled "tower" on the Wilshire facade, an entry embellished with plaster decoration on the west, and a cut away corner with a scalloped overhang. The two story portion of the building is largely intact. Some alterations to the one story wings to the north and west were made in 1939 to adapt the market, with fold-back doors, to an automobile showroom and (see continuation sheet)

servicing space. A front gable and a short "tower" were removed. However, another "tower," square in shape, with a double row of "X" vents and a small cupola, still anchors the inside corner of the building.

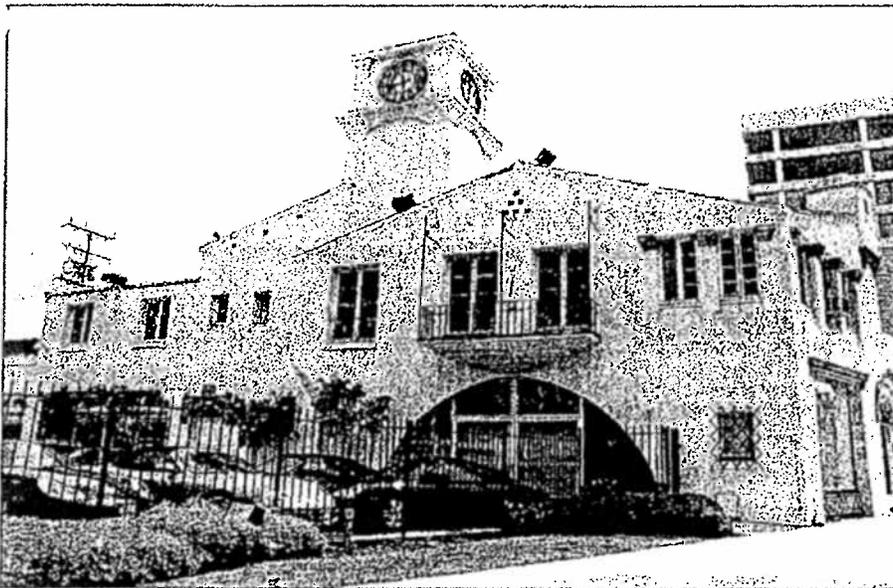
P5b Description/Date of Photo: June, 2004

This building appears in good condition with no significant alterations visible since the property was last evaluated in the 1985-1986 survey. It remains eligible for local listing or designation.

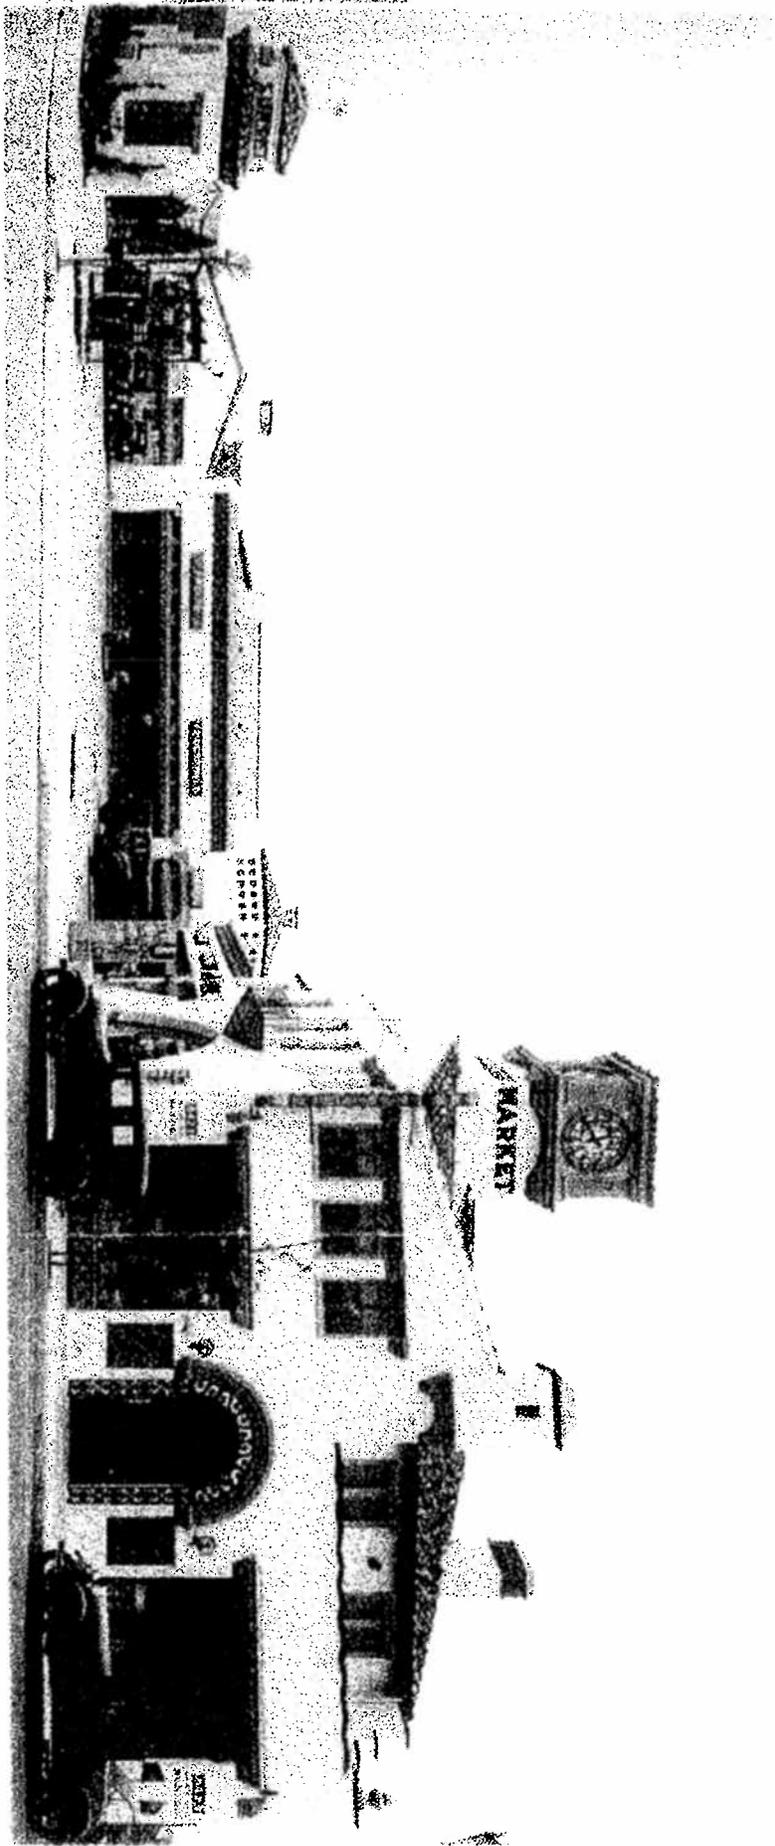
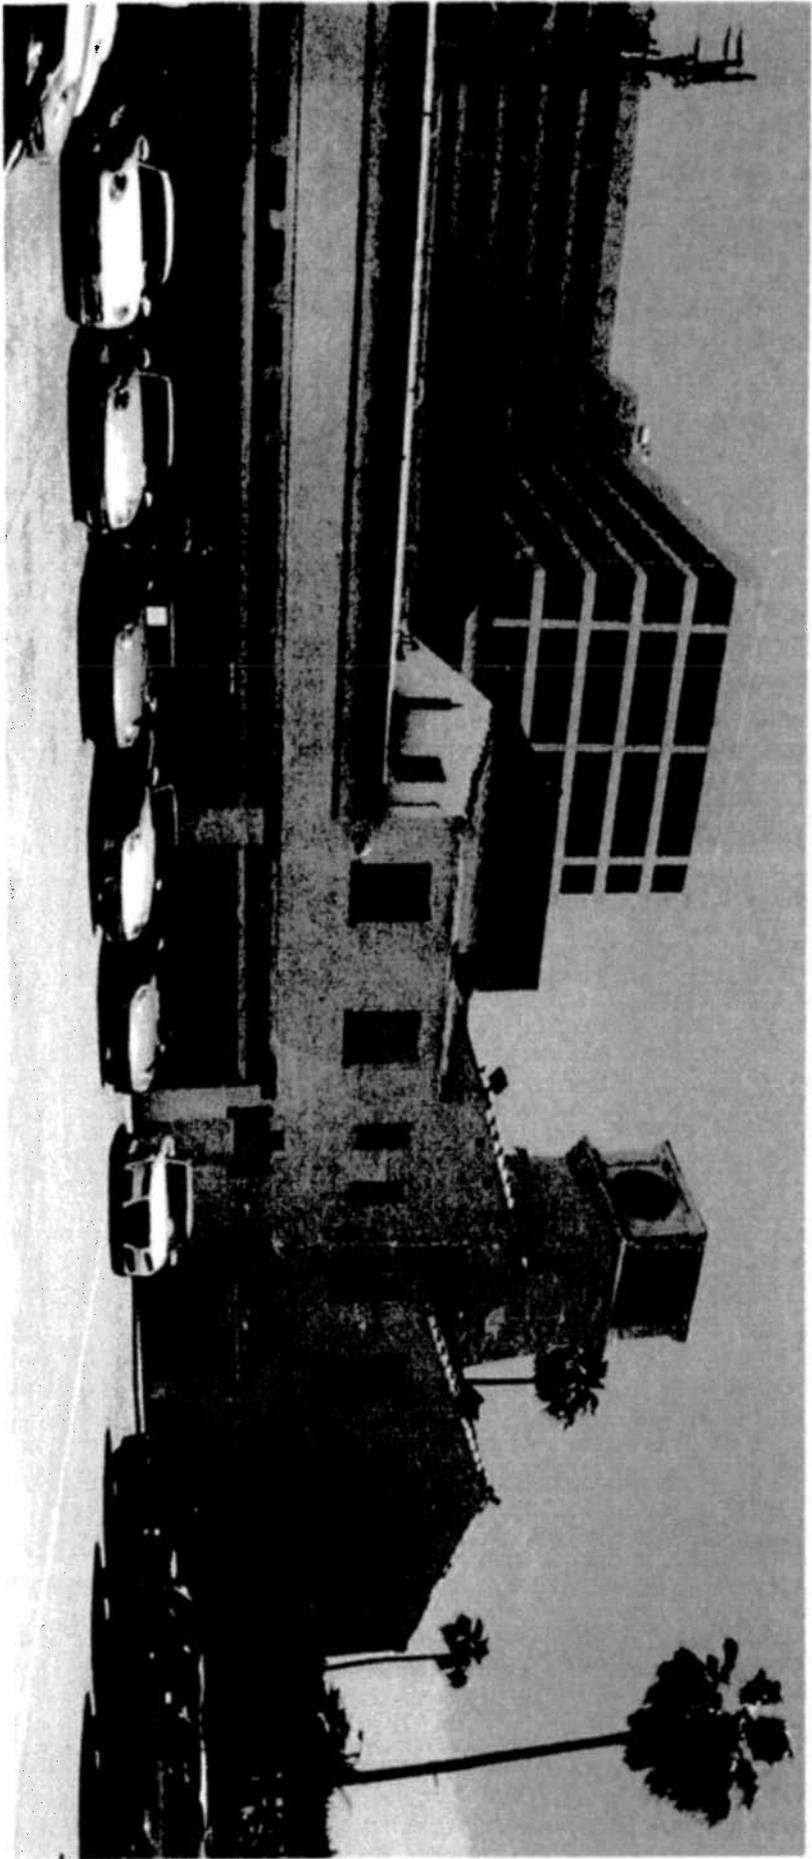
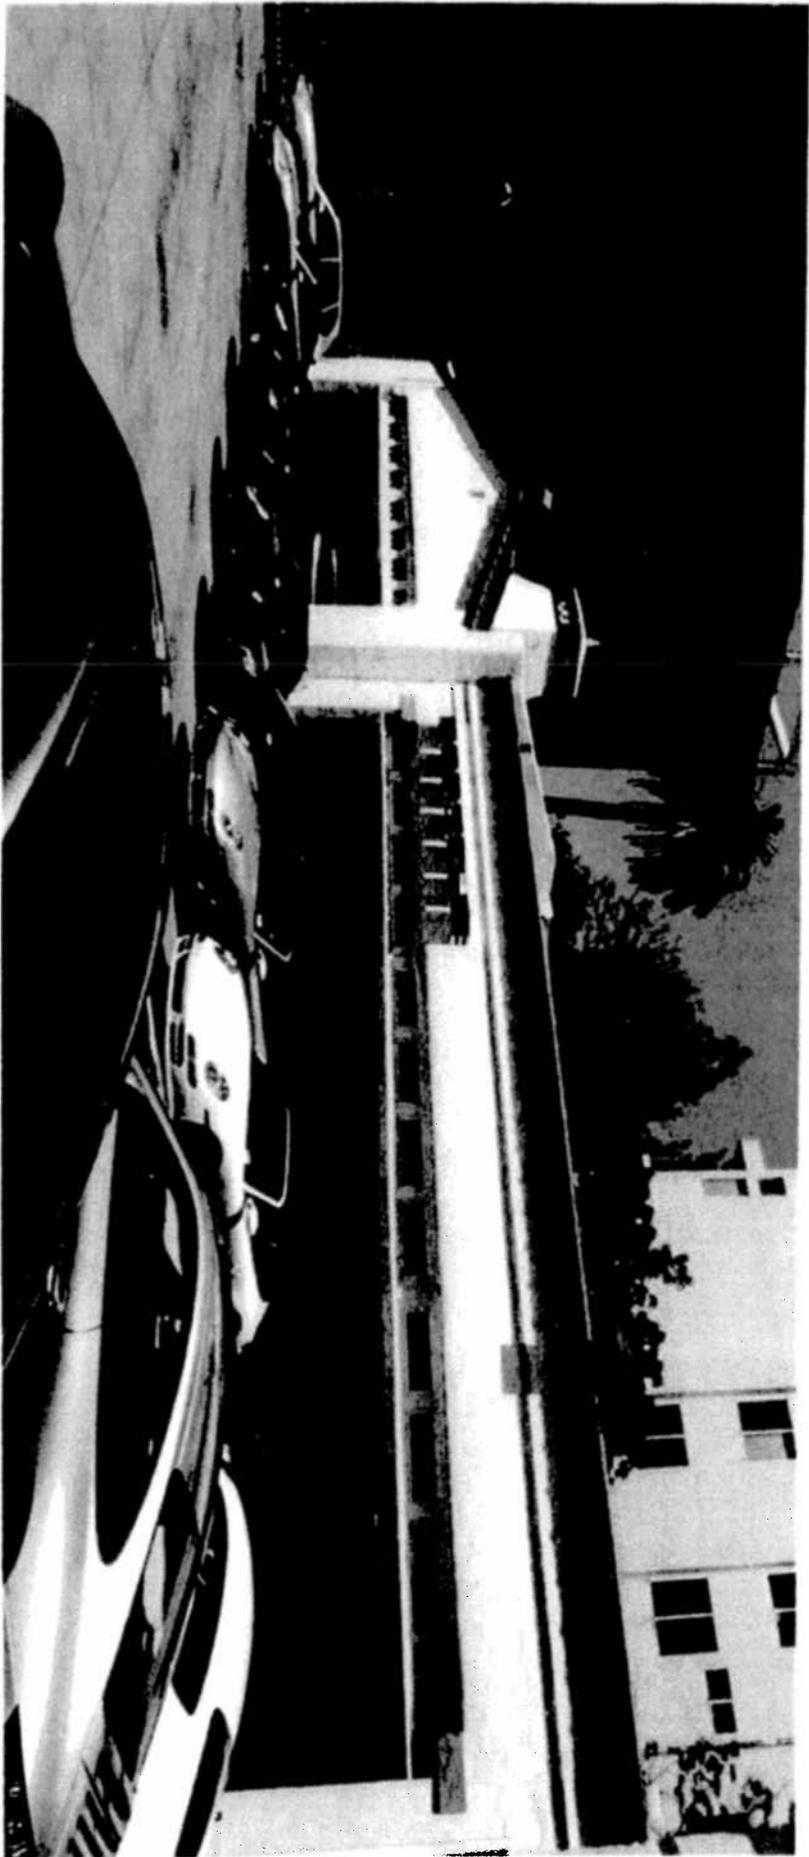
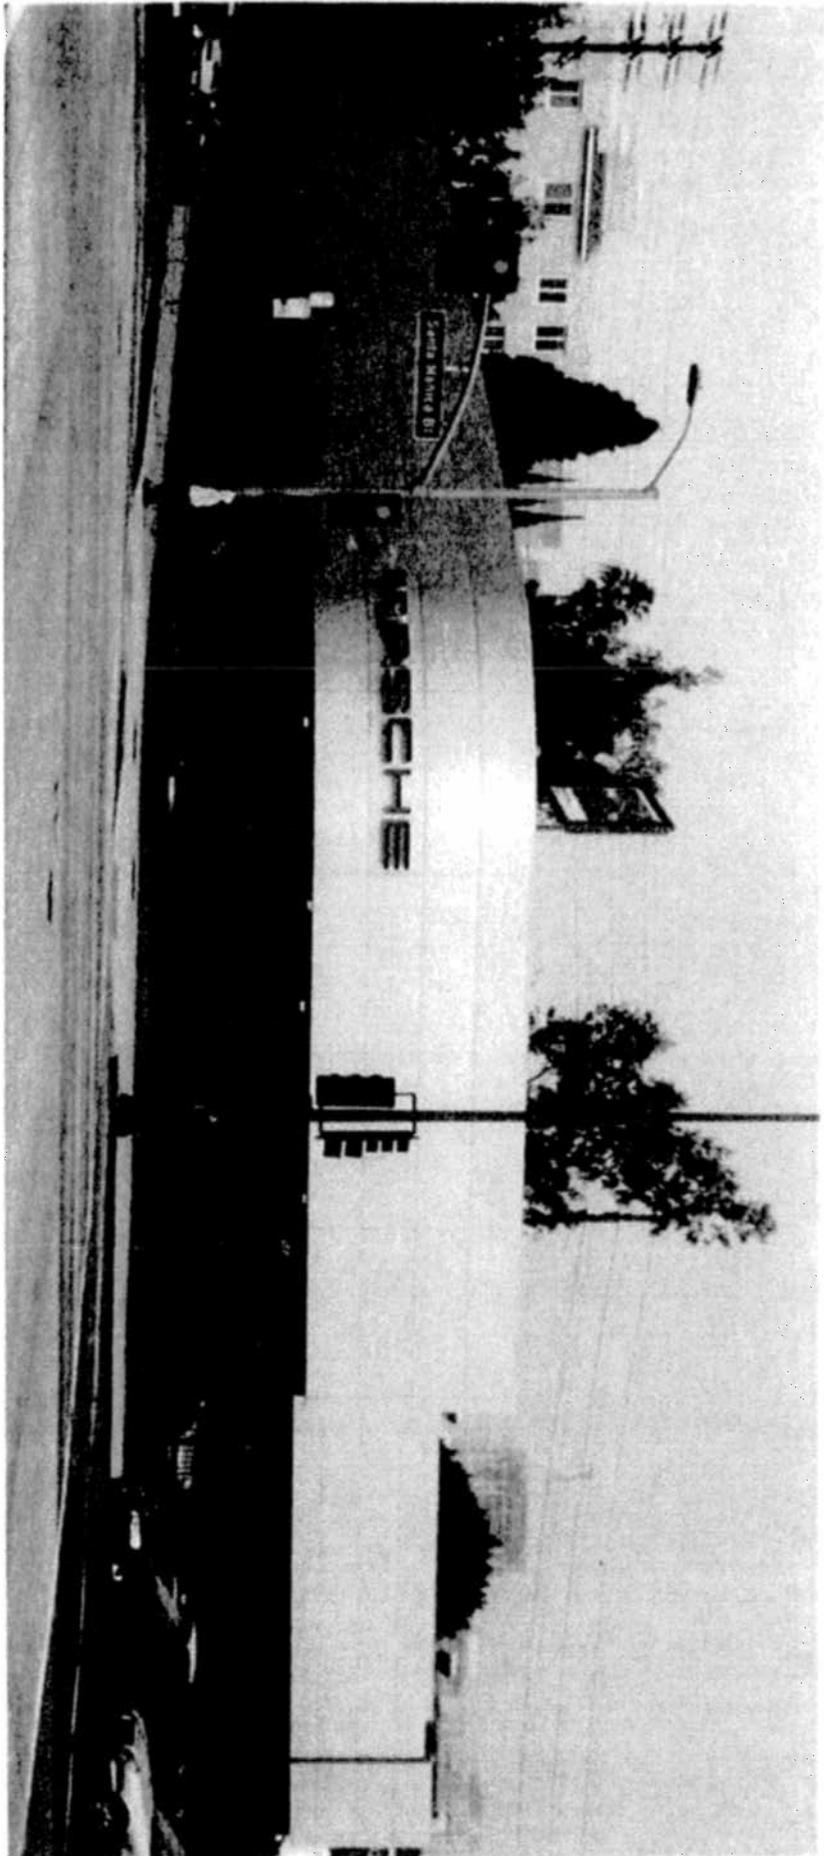
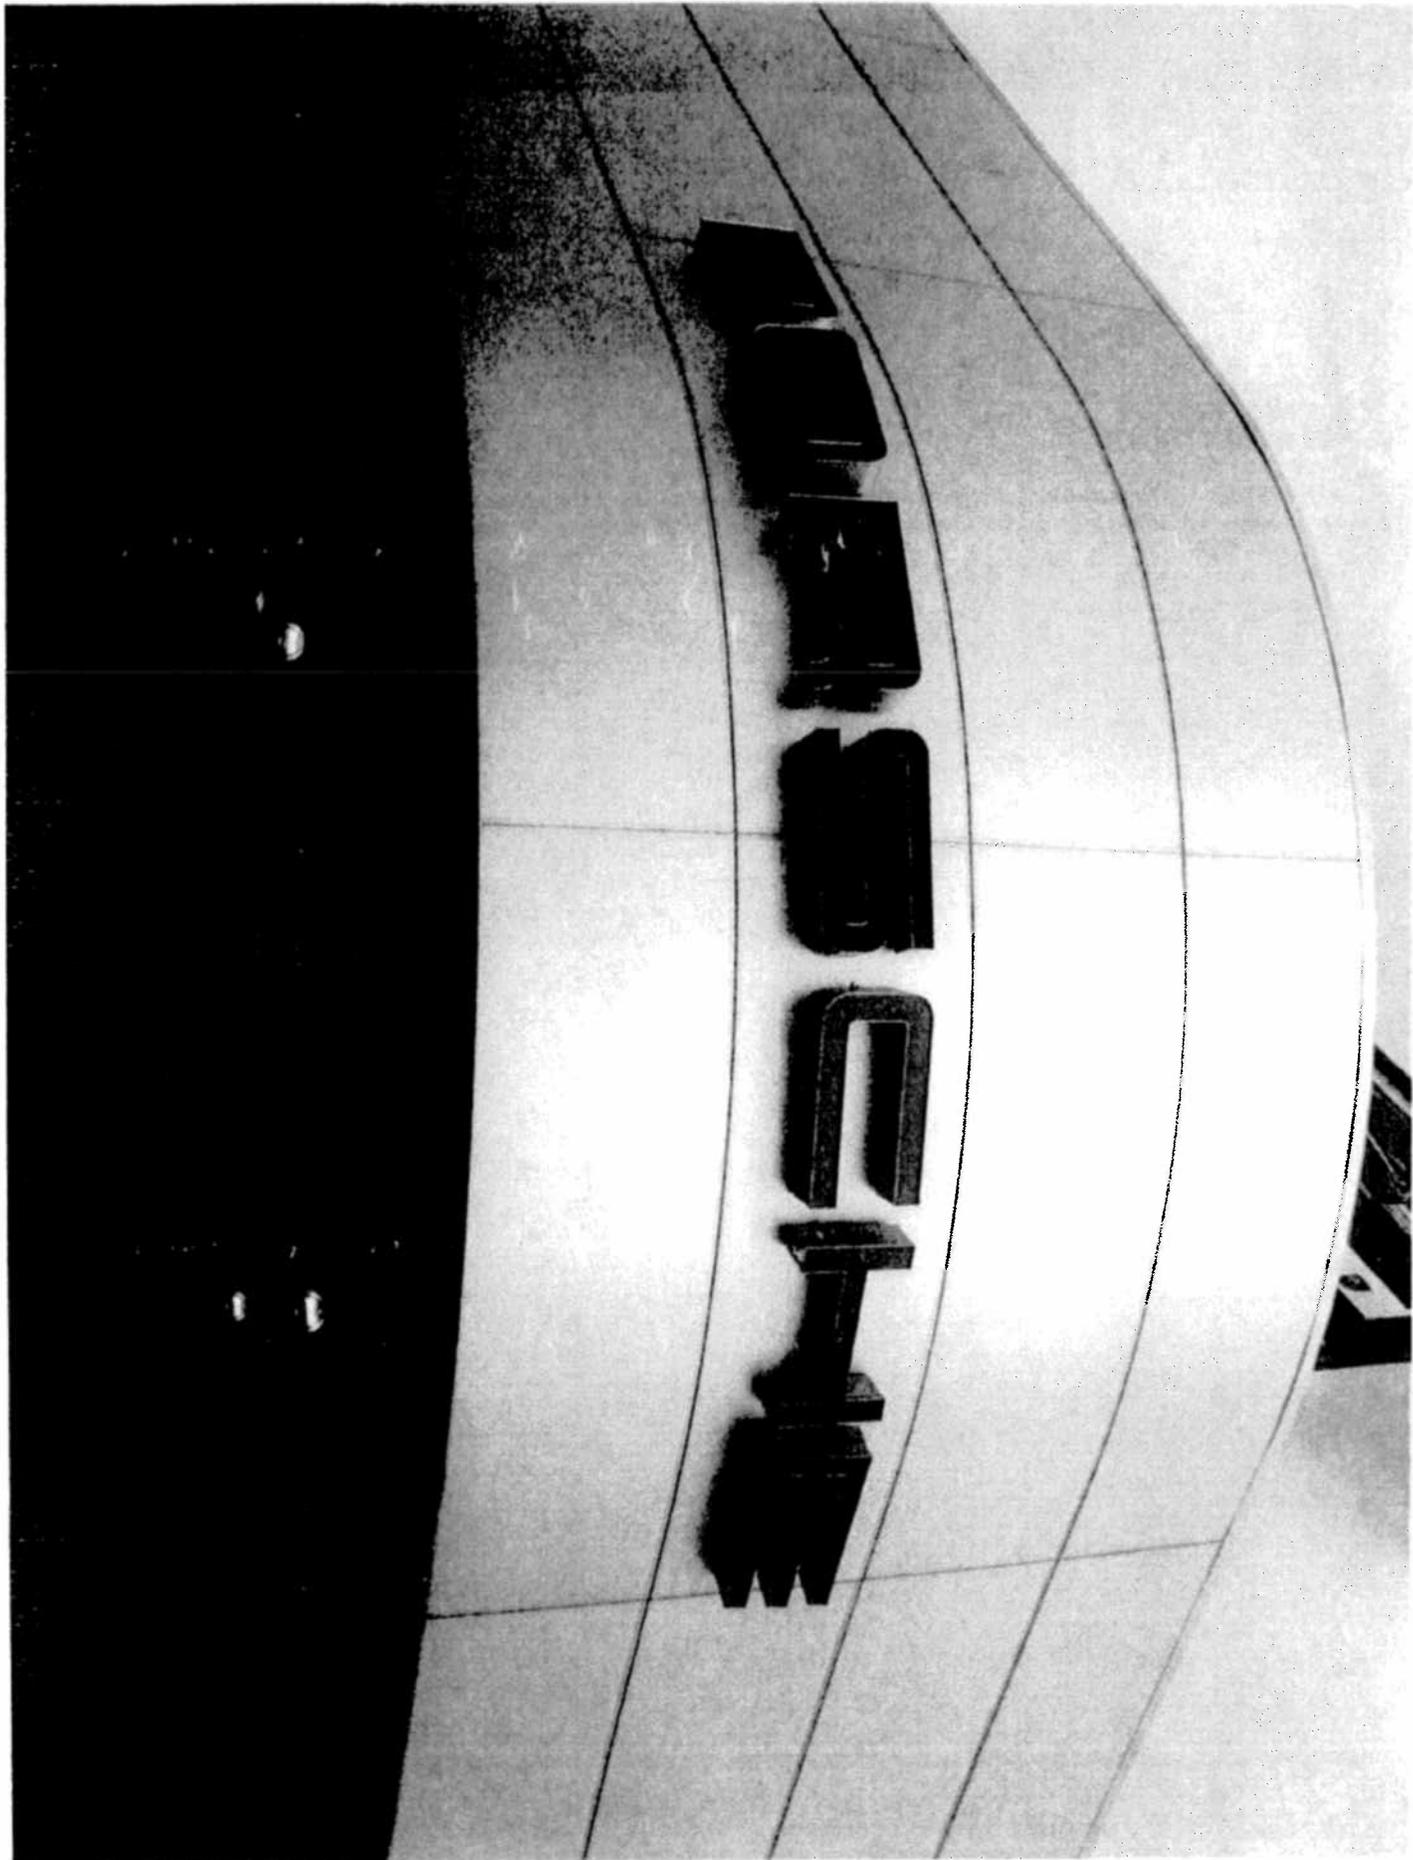
ATTACHMENT C
Plans and Photographs

- A new two-story high alucobond (aluminum composite material) freestanding screen mounted on posts a few feet in front of the existing building elevation facing Wilshire Boulevard (south elevation). A portion of the screen would also wrap around the west side of the elevation and would be visible from that side as well.
- Illuminated signage reading "PORSCHE Beverly Hills" would be included on the screen.

As proposed, the new façade element is radically different in design and is not compatible with the property's historic materials, features, size, scale and proportion, and massing. Further, the large, freestanding façade totally dominates and obscures the building's south elevation from view, which is considered a primary elevation. As such, this particular scope of work is inconsistent with the recommended approaches and treatment set forth in the *Standards*. The proposed work has the potential to adversely affect those qualities and characteristics of the building that qualify it for local landmark designation and as historical resource under CEQA.
