CITY OF BEVERLY HILLS  
**TRAFFIC & PARKING COMMISSION**

**TO:** Traffic & Parking Commission  
**FROM:** Aaron Kunz, Deputy Director of Transportation  
Martha Eros, Transportation Planner  
**SUBJECT:** Pedestrian Crossing Evaluation  
**ATTACHMENTS:** A. Fehr & Peers Memorandum  
B. Continental Crosswalk Markings and Signage  
C. Public Notice

## MEMORANDUM

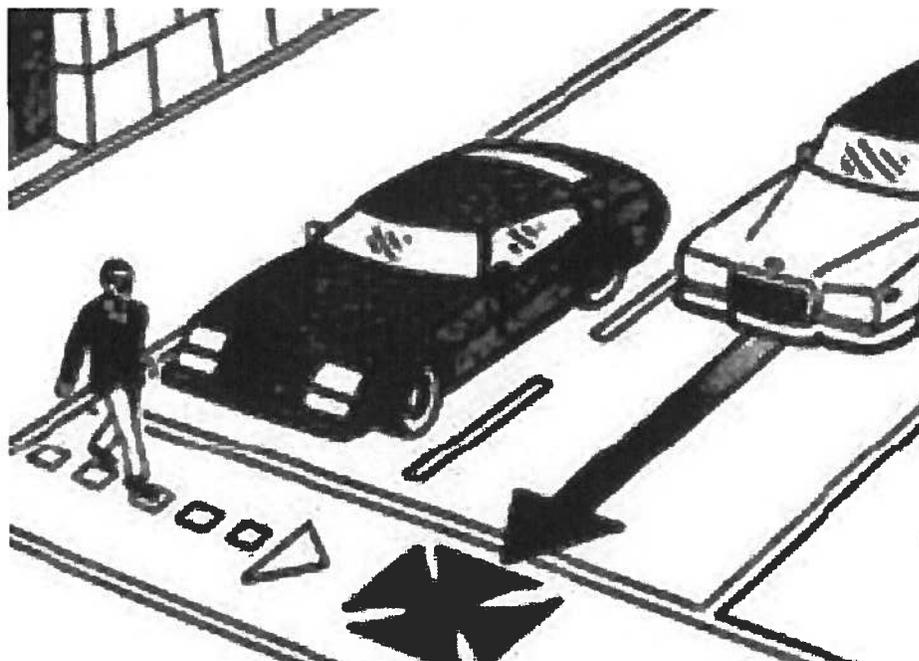
**Figure 1. Illustration of multiple-threat crashes.**

- Do Nothing – The combination of high vehicular volume and pedestrian activity results in a large number of conflicting movements. The multi-lane configuration further exacerbates the likelihood of a conflict given the potential for multiple-threat crashes. Multiple-threat crashes occur when a driver in one lane yields to a pedestrian in a crosswalk, obscuring the pedestrian from view of a driver in the adjacent lane, increasing the risk that the vehicle in the other lane will strike the pedestrian as the pedestrian clears the vehicle in the first lane and steps out in front of the second vehicle. Figure 1 illustrates a typical multiple-threat scenario. As such, maintaining the existing condition is not recommended.

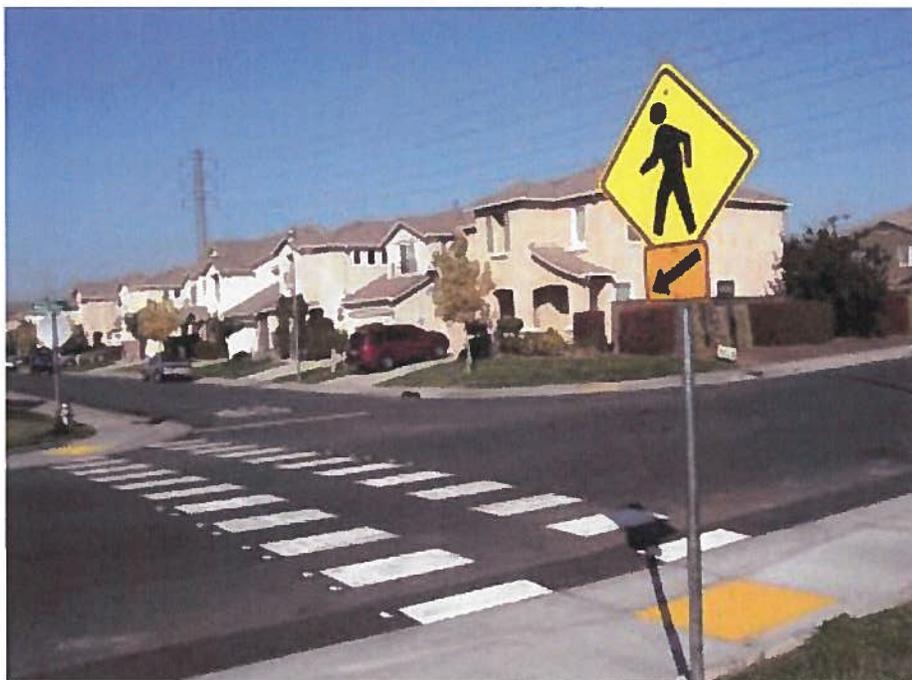
*Triple-four high visibility crosswalk or continental crosswalk.* Crosswalks with the triple-four pattern are so called because an unpainted center channel is bound with high-visibility striped markings on either side, with the markings and the center channel forming three 4-foot wide zones. The center channel guides pedestrians along the safest path within the crossing and prevents pedestrians from straying outside the crossing. Reflectors placed facing on-coming traffic in each direction of travel provide an additional alert to drivers about the crosswalk. See Figure 3 for an illustration of a triple-four crosswalk. Alternatively, a continental crosswalk can be installed as it provides a similarly high level of visibility to the on-coming driver.

**Figure 3. Triple-four high visibility crosswalk.**

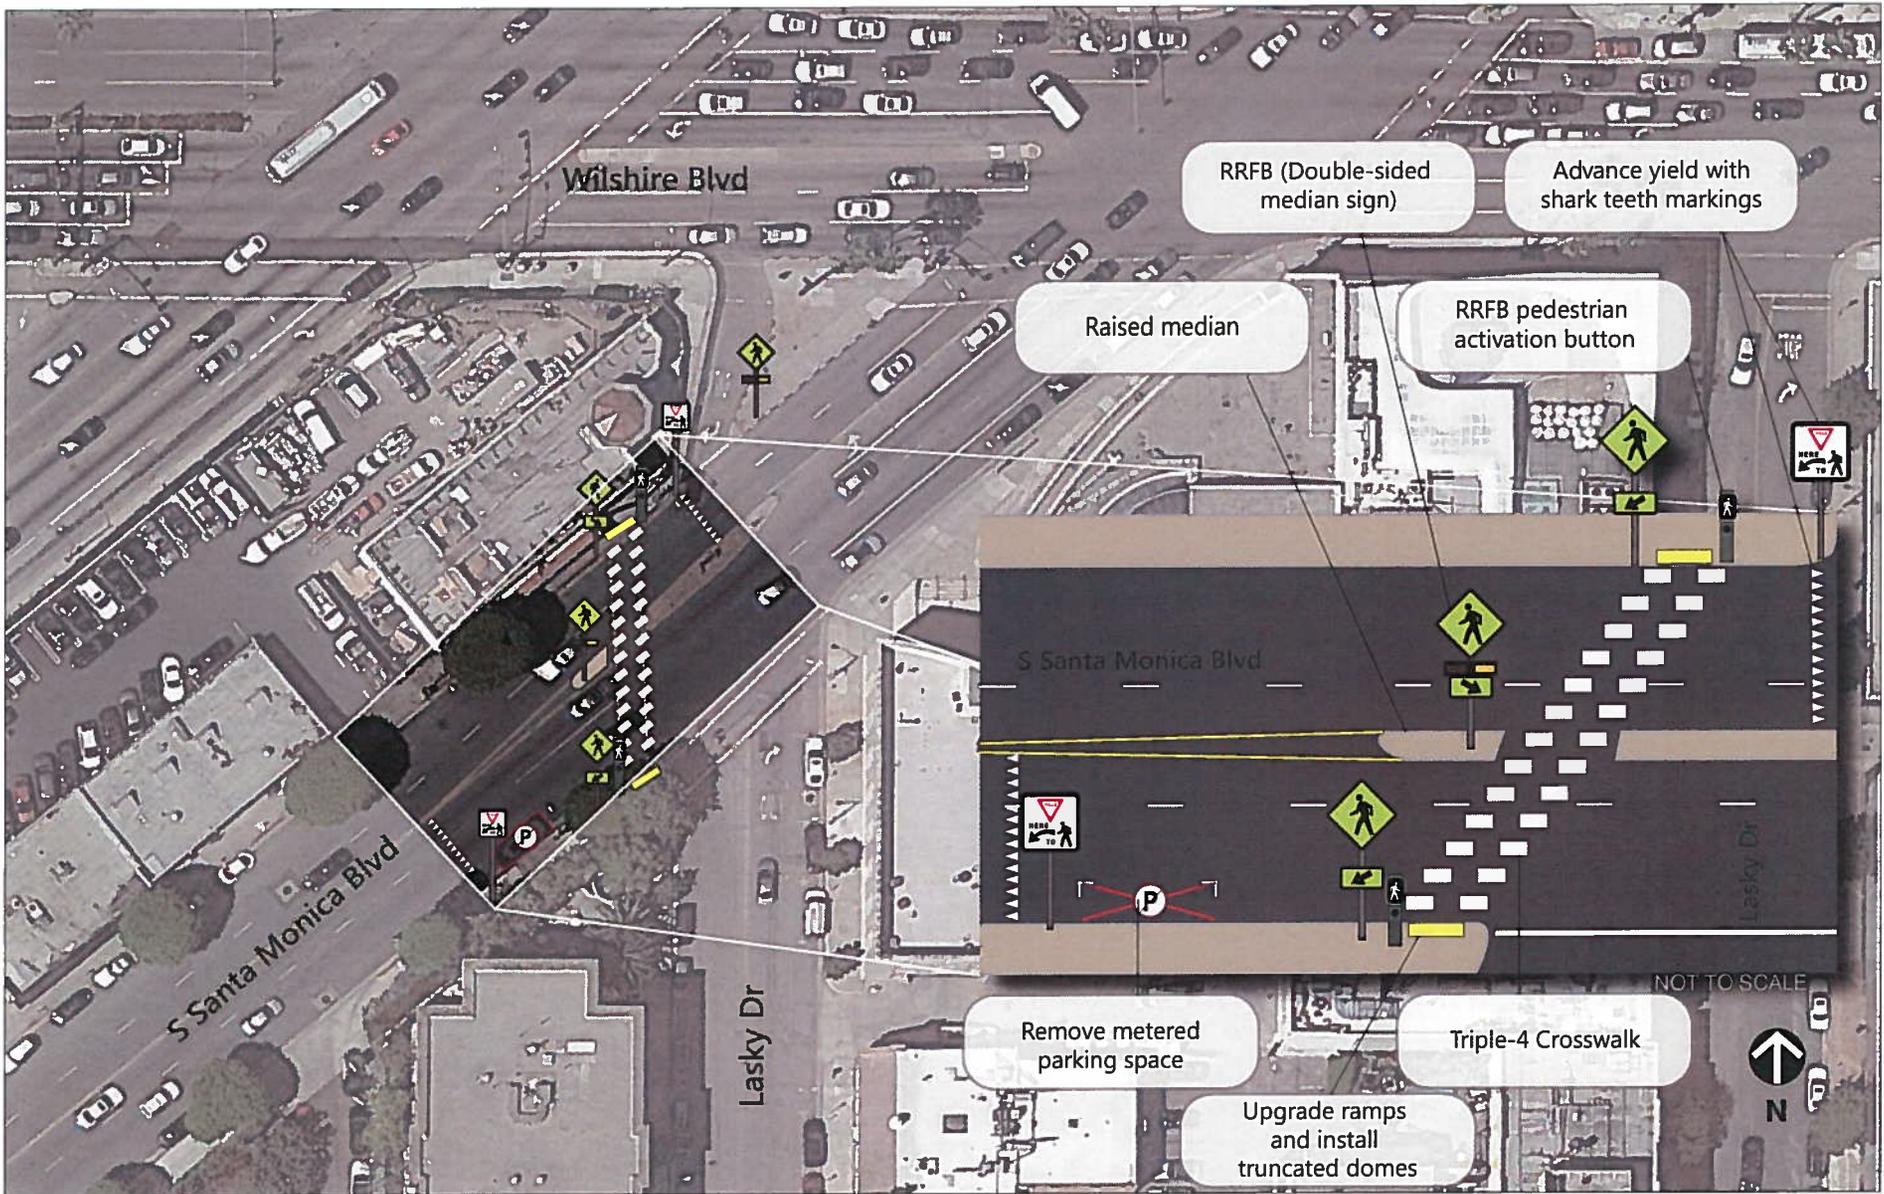
The recommended improvements for the uncontrolled crossing across South Santa Monica Boulevard at Lasky Drive, illustrated in Figure 2 (next page) will maintain existing crosswalk operations without impacting traffic operations at the signalized intersection with Wilshire Boulevard, while providing greater comfort for pedestrians utilizing the facility, more separation between vehicles and pedestrians, and enhanced warning for motorists approaching the crosswalk. The recommended improvements include the following:

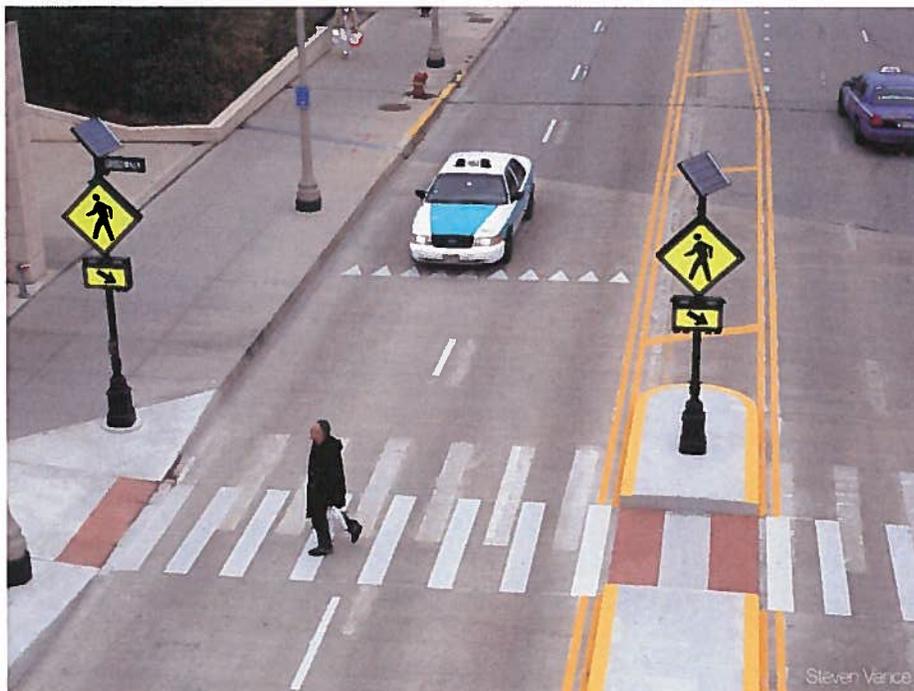
*Rectangular Rapid Flashing Beacon (RRFB).* RRFBs are user-actuated amber LEDs that supplement warning signs at unsignalized intersections or mid-block crosswalks. RRFBs use an irregular “stutter” flash pattern similar to emergency flashers on police vehicles, and have been shown to significantly increase driver yielding behavior at crosswalks when supplementing standard crossing warning signs and markings. One FHWA study showed them to also be significantly more effective than a traditional overhead beacon. We recommend installing three RRFBs at the following locations: two in the new median to the immediate west of the crosswalk facing eastbound and westbound traffic, and one in the pork chop island adjacent to and facing the southbound right turn lane from Santa Monica Boulevard. See Figure 4 for an example of RRFBs being used in conjunction with a raised median.

**Figure 4. RRFBs.**

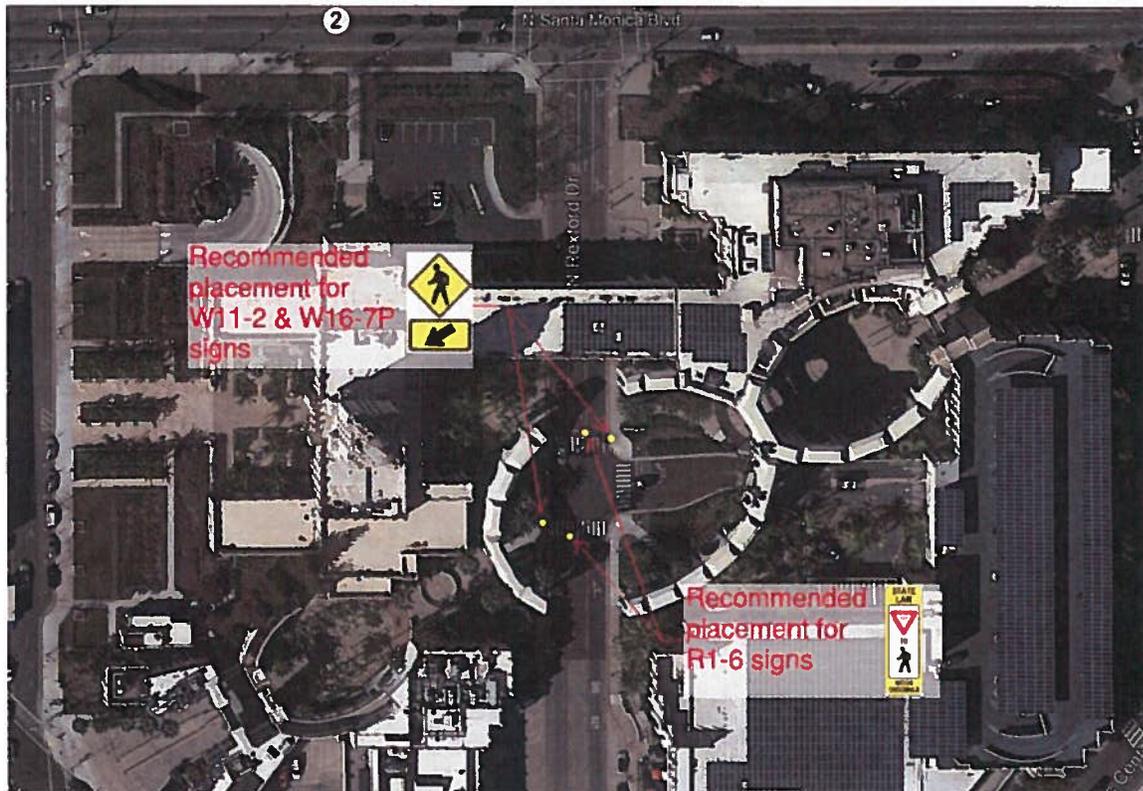
Figure 6 shows the study location and the recommended placement of the aforementioned signs. Staff has already ordered the recommended in-street signs.

**Figure 6. North Rexford Drive Signage Recommendations**

According to the CA MUTCD in Section 2B.11, the yield to pedestrians sign (R1-5) shall be used when yield lines are used in advance of a marked crosswalk that crosses an uncontrolled multi-lane approach. There are no other applications specified in the CA MUTCD for the use of this sign. Therefore, we recommend replacing existing signage with a pedestrian crossing (W11-2) warning sign, supplemented with a diagonal arrow (W16-7), post mounted with a seven foot clearance to more conspicuously warn motorists of the presence of pedestrians.

The CA MUTCD provides an option in Section 2B.12 to place In-Street Pedestrian Crossing signs (R1-6) at unsignalized pedestrian crosswalks to remind users of laws pertaining to right-of-way. When used, these signs are recommended to be placed in the roadway at the crosswalk location on the center line, on a lane line, or on a median island.

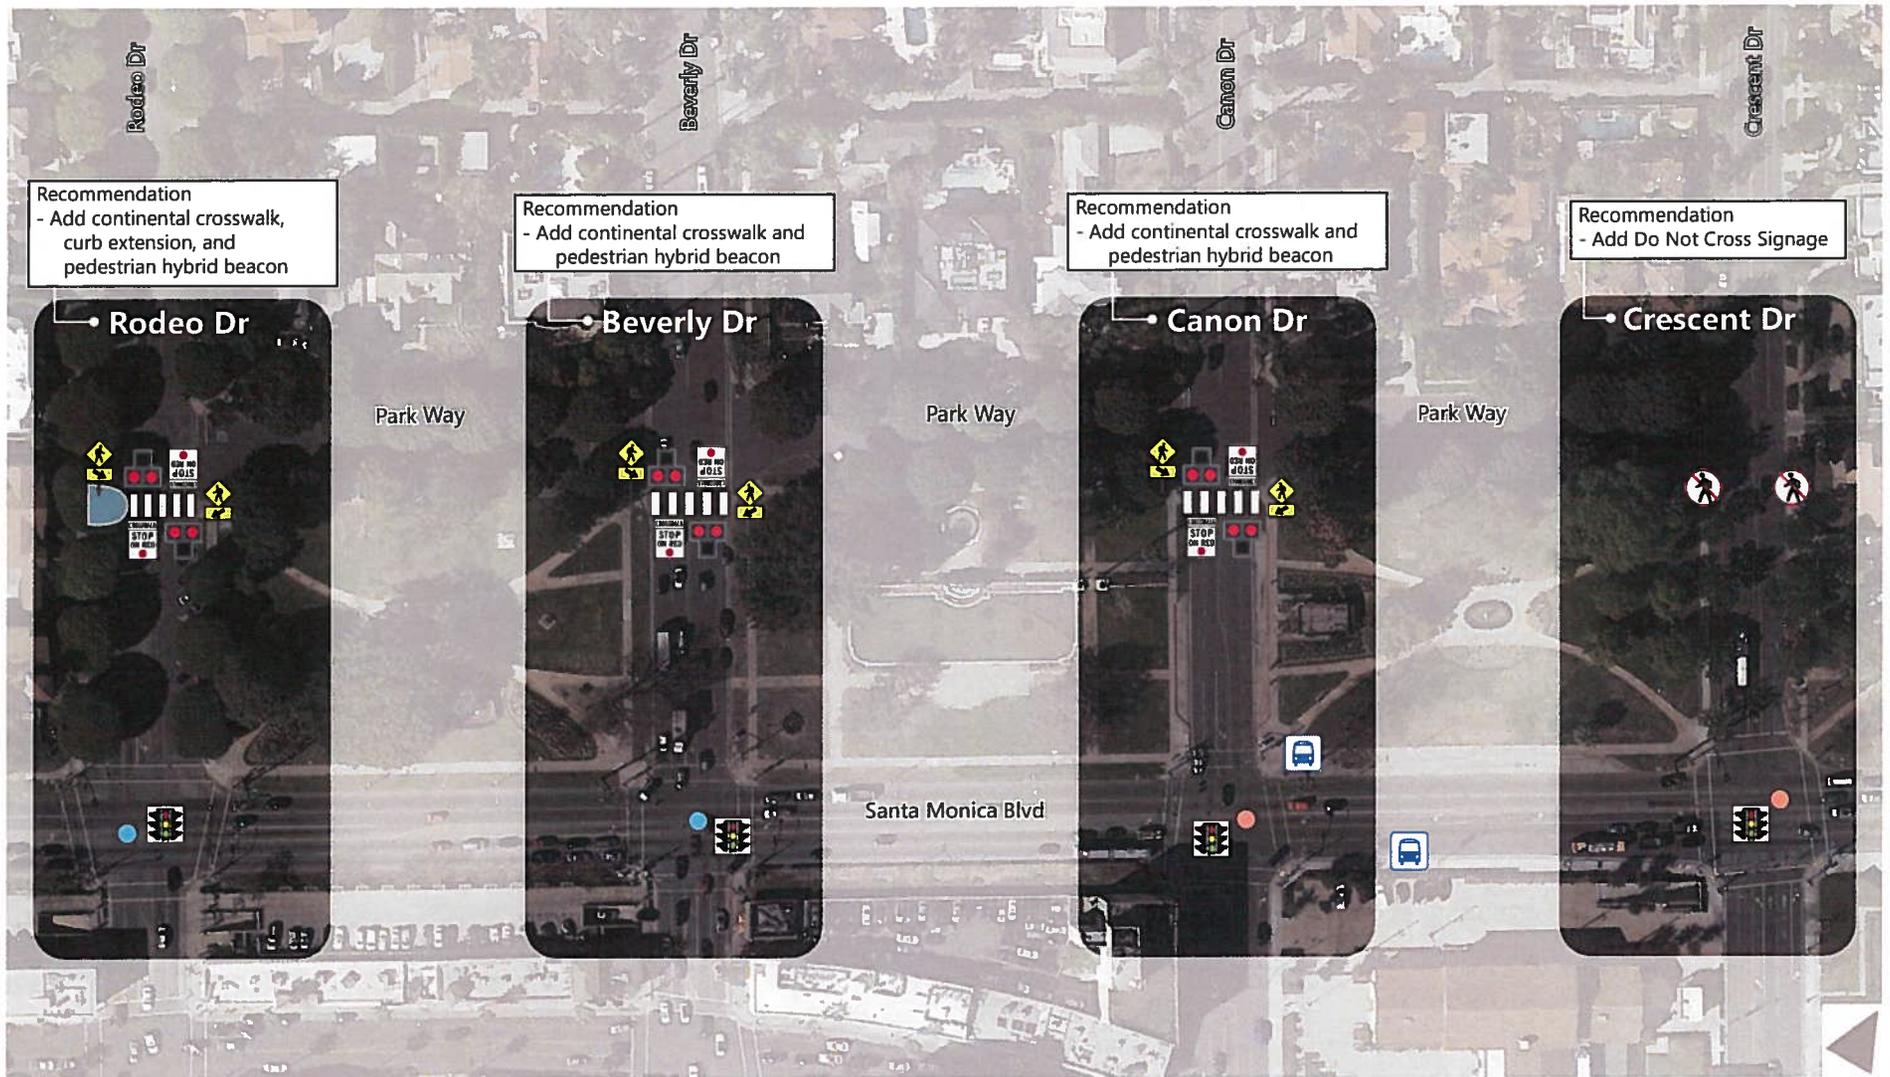
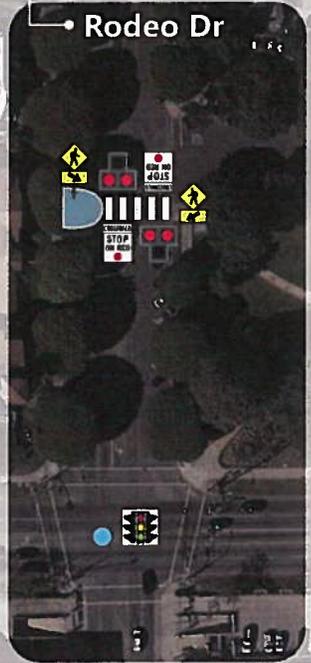
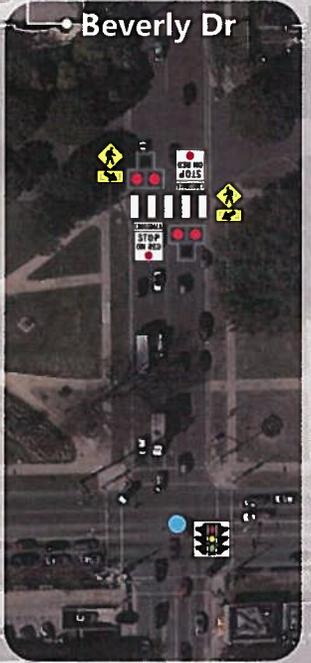
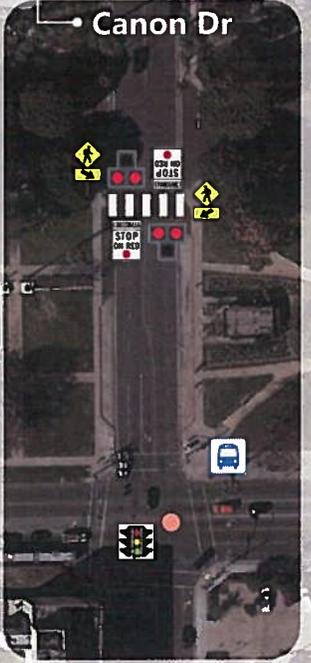
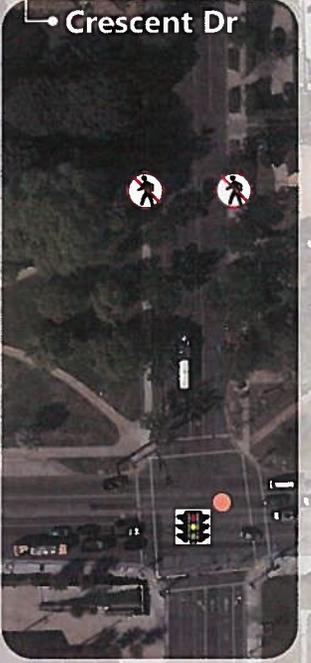
Figure 7  
 Rodeo Drive to Crescent Drive

All of the recommended improvements along Park Way are illustrated on Figure 7.

**Recommendation**  
 - Add continental crosswalk, curb extension, and pedestrian hybrid beacon

**Recommendation**  
 - Add continental crosswalk and pedestrian hybrid beacon

**Recommendation**  
 - Add Do Not Cross Signage

Given the high pedestrian activity at Rodeo Drive, Beverly Drive, and Canon Drive, a marked crosswalk with high level safety enhancements are recommended, including a pedestrian hybrid beacon and a continental crosswalk along the south leg of each intersection. The fact that a large number of crossings take place across Rodeo Drive where there is currently crossing prohibition signagedemonstrates the demand for crossing at this location. An additional feature recommended at Rodeo Drive is a curb extension (or bulb-out) on the west side of the street to improve visibility associated with the curvature in the roadway, on-street parking and a large tree immediately north of where the crosswalk would be located. Removal or relocation of one accessible parking stall would also be needed.

Due to the lower volumes observed on Crescent Drive (22 during the peak hour) as well as its location at the terminus of Beverly Gardens Park with no path continuation on the east side, a marked crosswalk is not recommended at this location. Instead, crossing prohibition signage is recommended directing pedestrians to the signalized crossing at Santa Monica Boulevard.
