CITY OF BEVERLY HILLS  
**TRAFFIC & PARKING COMMISSION**

**TO:** Traffic & Parking Commission  
**FROM:** Aaron Kunz, Deputy Director of Transportation  
**SUBJECT:** Crosswalks in Beverly Gardens Park  
**ATTACHMENTS:** A. Fehr & Peers Report

**Subject: Beverly Hills Decomposed Granite Path Pedestrian Crossing Evaluation**

This memorandum summarizes the results of an evaluation of pedestrian crossings along the decomposed granite path adjacent to and north of Santa Monica Boulevard North and Wilshire Boulevard in the City of Beverly Hills to determine appropriate crossing treatments.

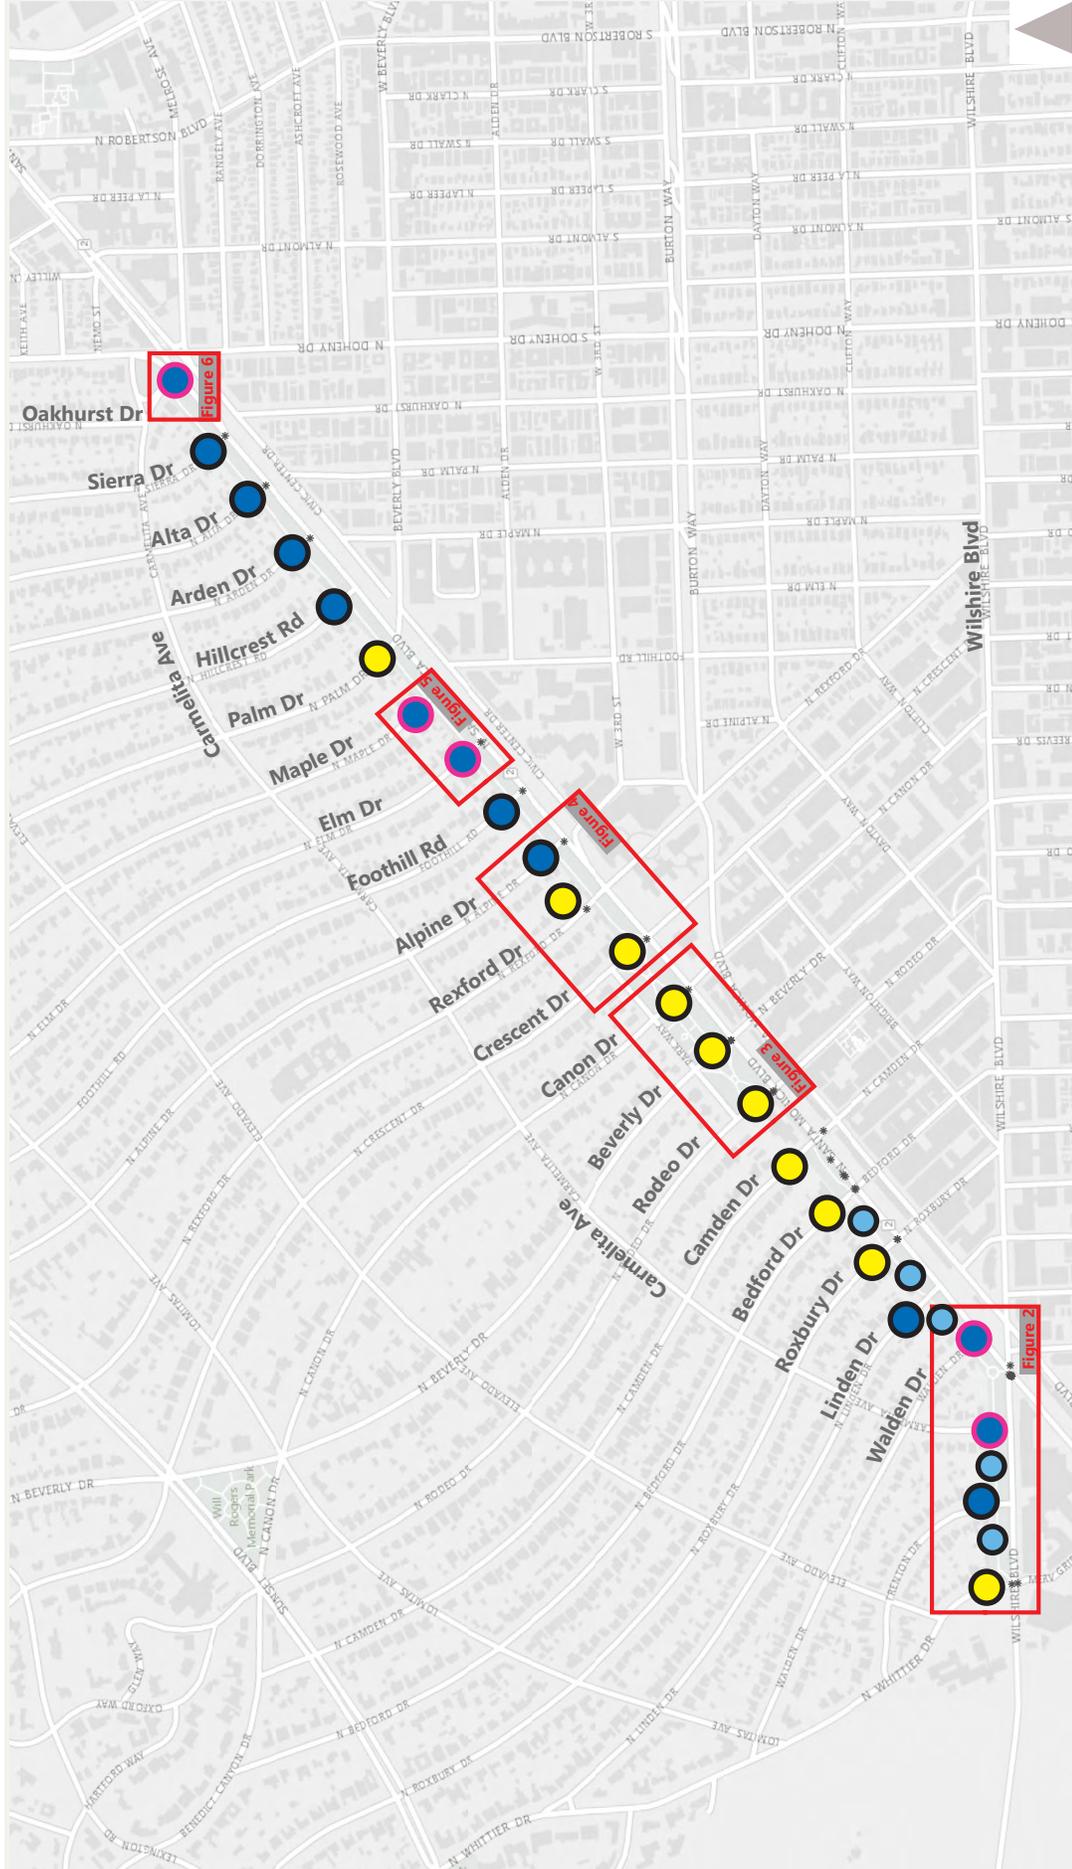
Figure 1  
Study Area

**Path Crossing Location Type**

- Collision
- Alley
- Adjacent to Stop Controlled Intersection
- Adjacent to Signalized Intersection
- Includes Modifications to Standard Treatments Proposed

There are five alley crossings along the corridor that are each approximately 20 feet wide. The alleys provide access to residential garages and garbage bins for trash collection services. As shown on Figure 1, the five alley locations (shown with a light blue circle) are:

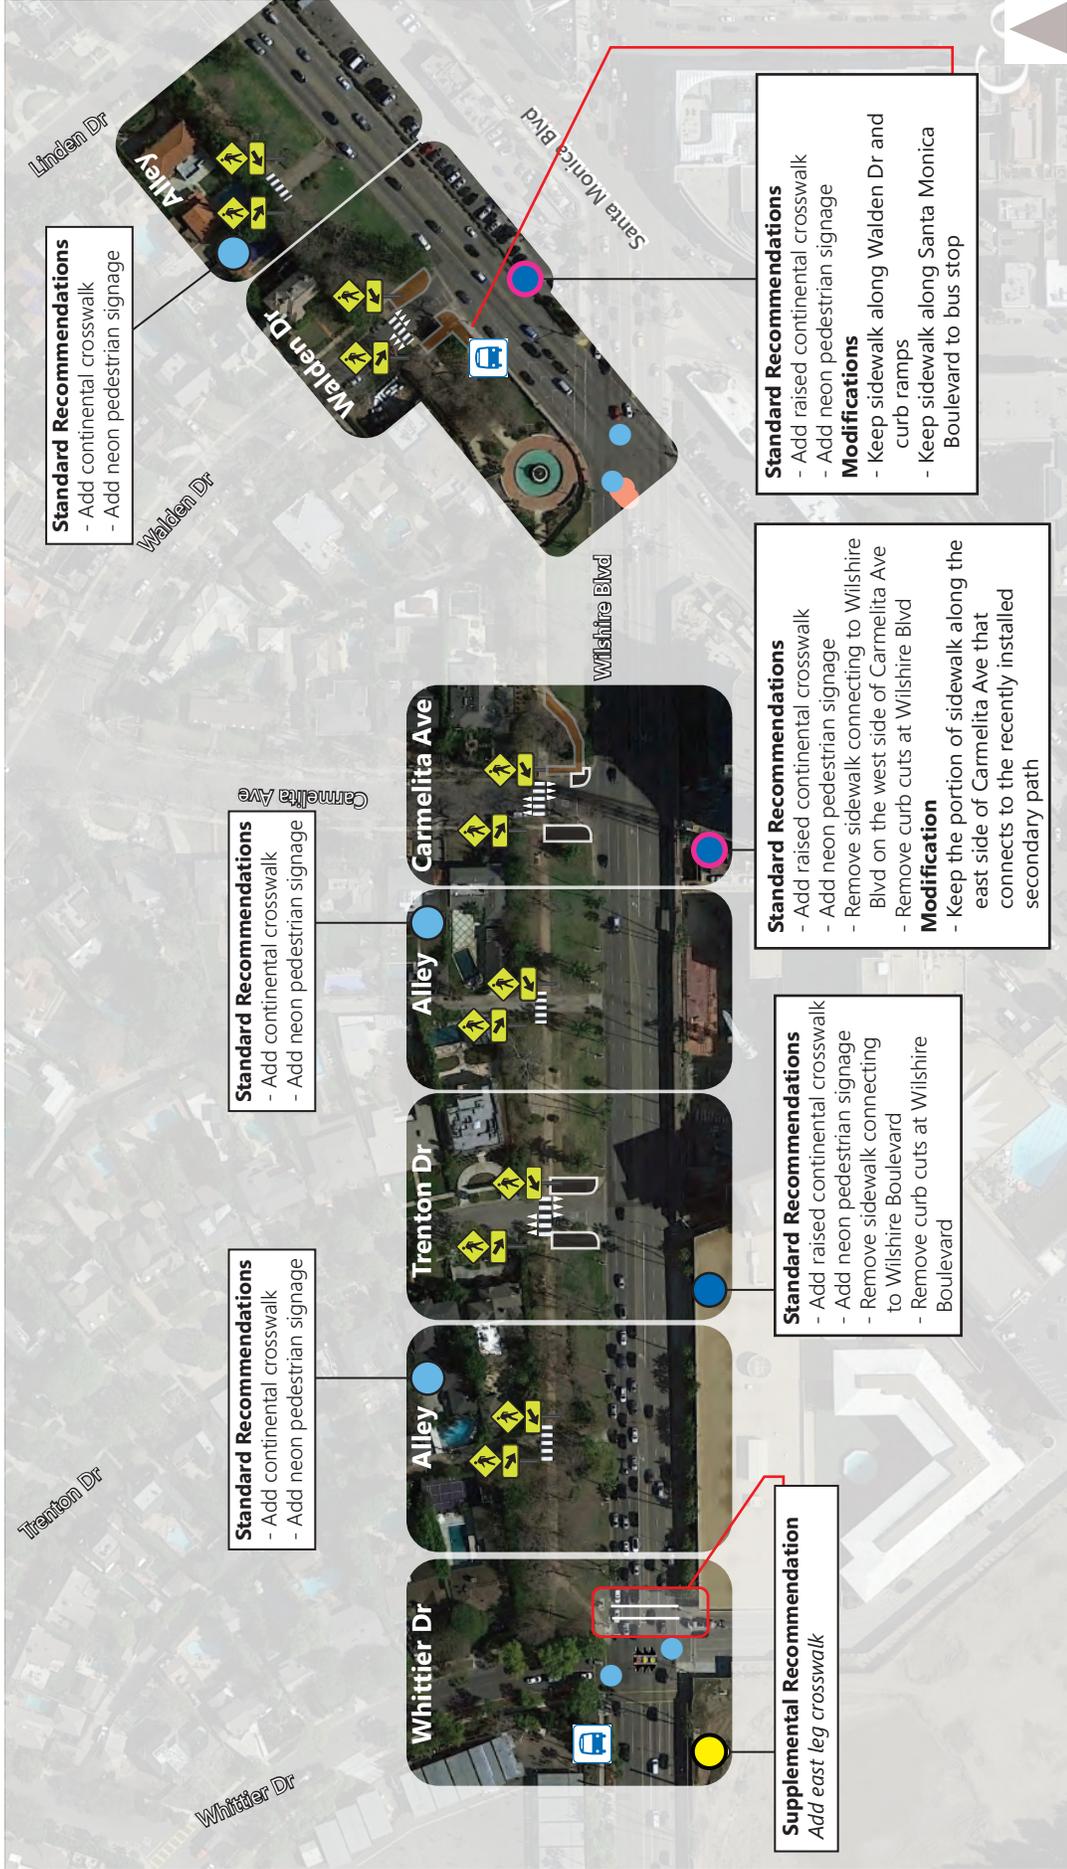
Figure 2

# Whittier Drive to Alley East of Walden Drive

Table 1 presents those locations for which the standard treatment is recommended and where some modification is recommended to either preserve existing secondary paths at Carmelita Avenue (Figure 2), Elm Drive (Figure 5), and Maple Drive (Figure 5) or to maintain connectivity for bus passengers at Walden Drive (Figure 2).

Minor Street	Parallel Major Street	Remove Path Connection to Mid-Block Crossing	Add Direct Connection to Signalized Crossing	Supplemental Improvements
Whittier Drive (Figure 2)	Wilshire Boulevard	N/A	N/A	Add east-leg crosswalk
Roxbury Drive	Santa Monica Boulevard	Both sides	West side only	N/A
Bedford Drive	Santa Monica Boulevard	N/A	N/A	Remove sidewalk between Bedford Drive and Camden Drive on the north side and contiguous with Santa Monica Boulevard
Camden Drive	Santa Monica Boulevard	N/A	N/A	Remove sidewalk between Bedford Drive and Camden Drive on the north side and contiguous with Santa Monica Boulevard
Rodeo Drive (Figure 3)	Santa Monica Boulevard	N/A	N/A	Add curb extensions to the north leg to reduce crossing distance and vehicle speeds
Beverly Drive (Figure 3)	Santa Monica Boulevard	Both sides	N/A	
Canon Drive (Figure 3)	Santa Monica Boulevard	N/A	N/A	Add "Do Not Cross" signs at the termination of the two midblock paths on either side of Canon Drive

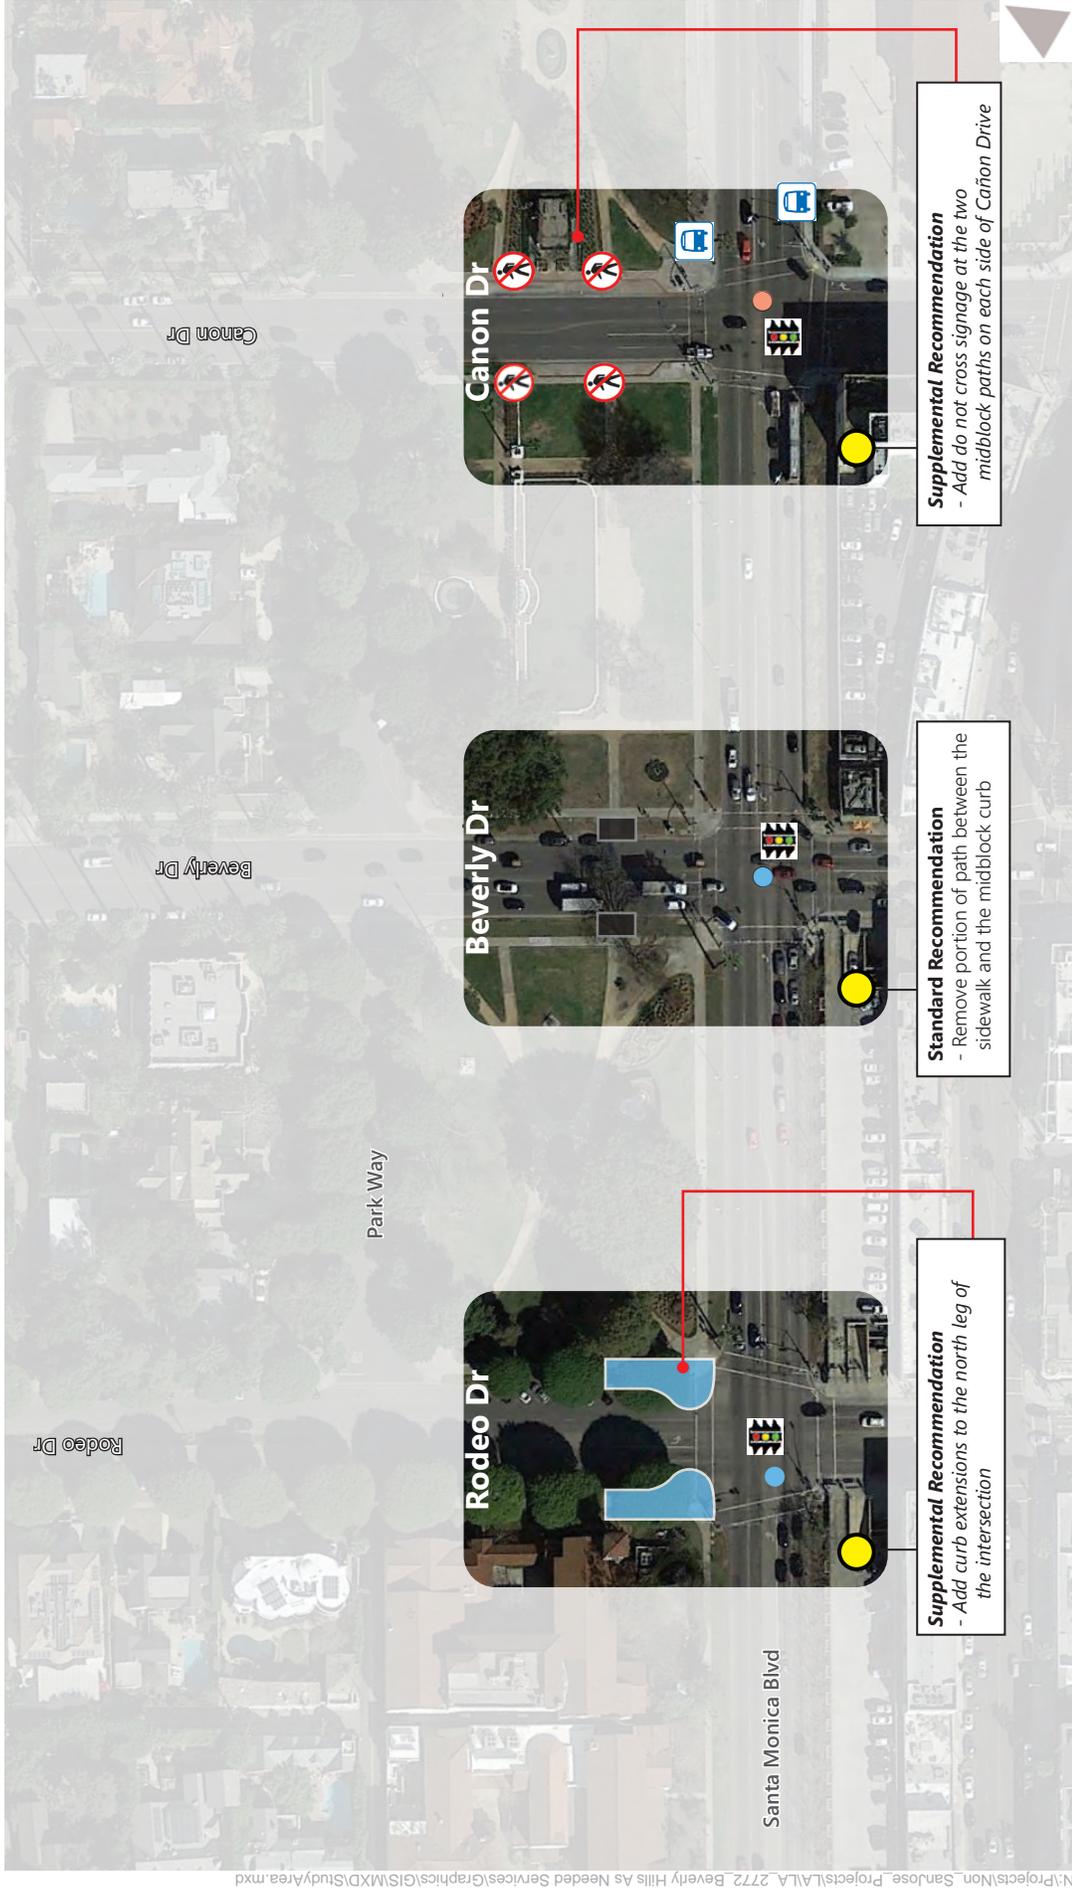
Figure 3

Rodeo Drive to Canon Drive

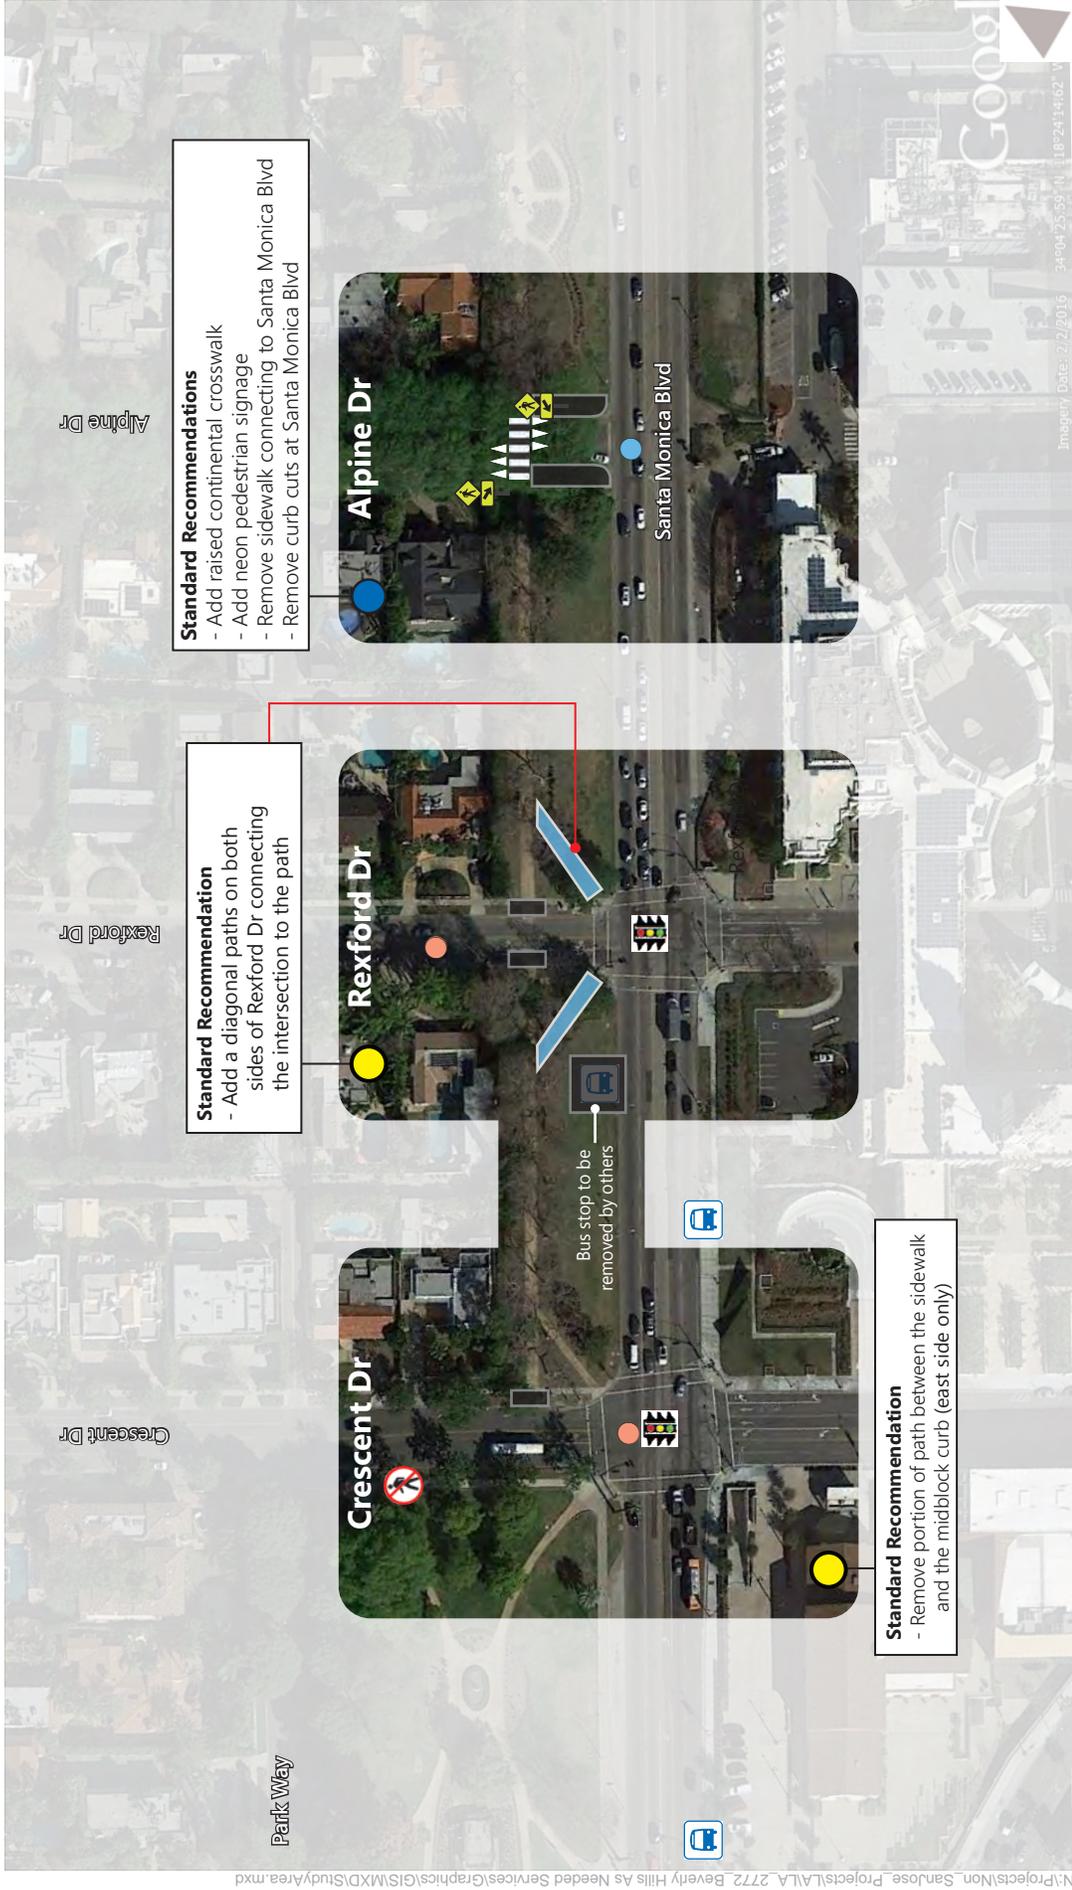
Figure 4  
Crescent Drive to Alpine Drive

Crescent Drive (Figure 4)	Santa Monica Boulevard	East side only	N/A	
Rexford Drive (Figure 4)	Santa Monica Boulevard	Both sides	Both sides	
Palm Drive	Santa Monica Boulevard	Both sides	Both sides

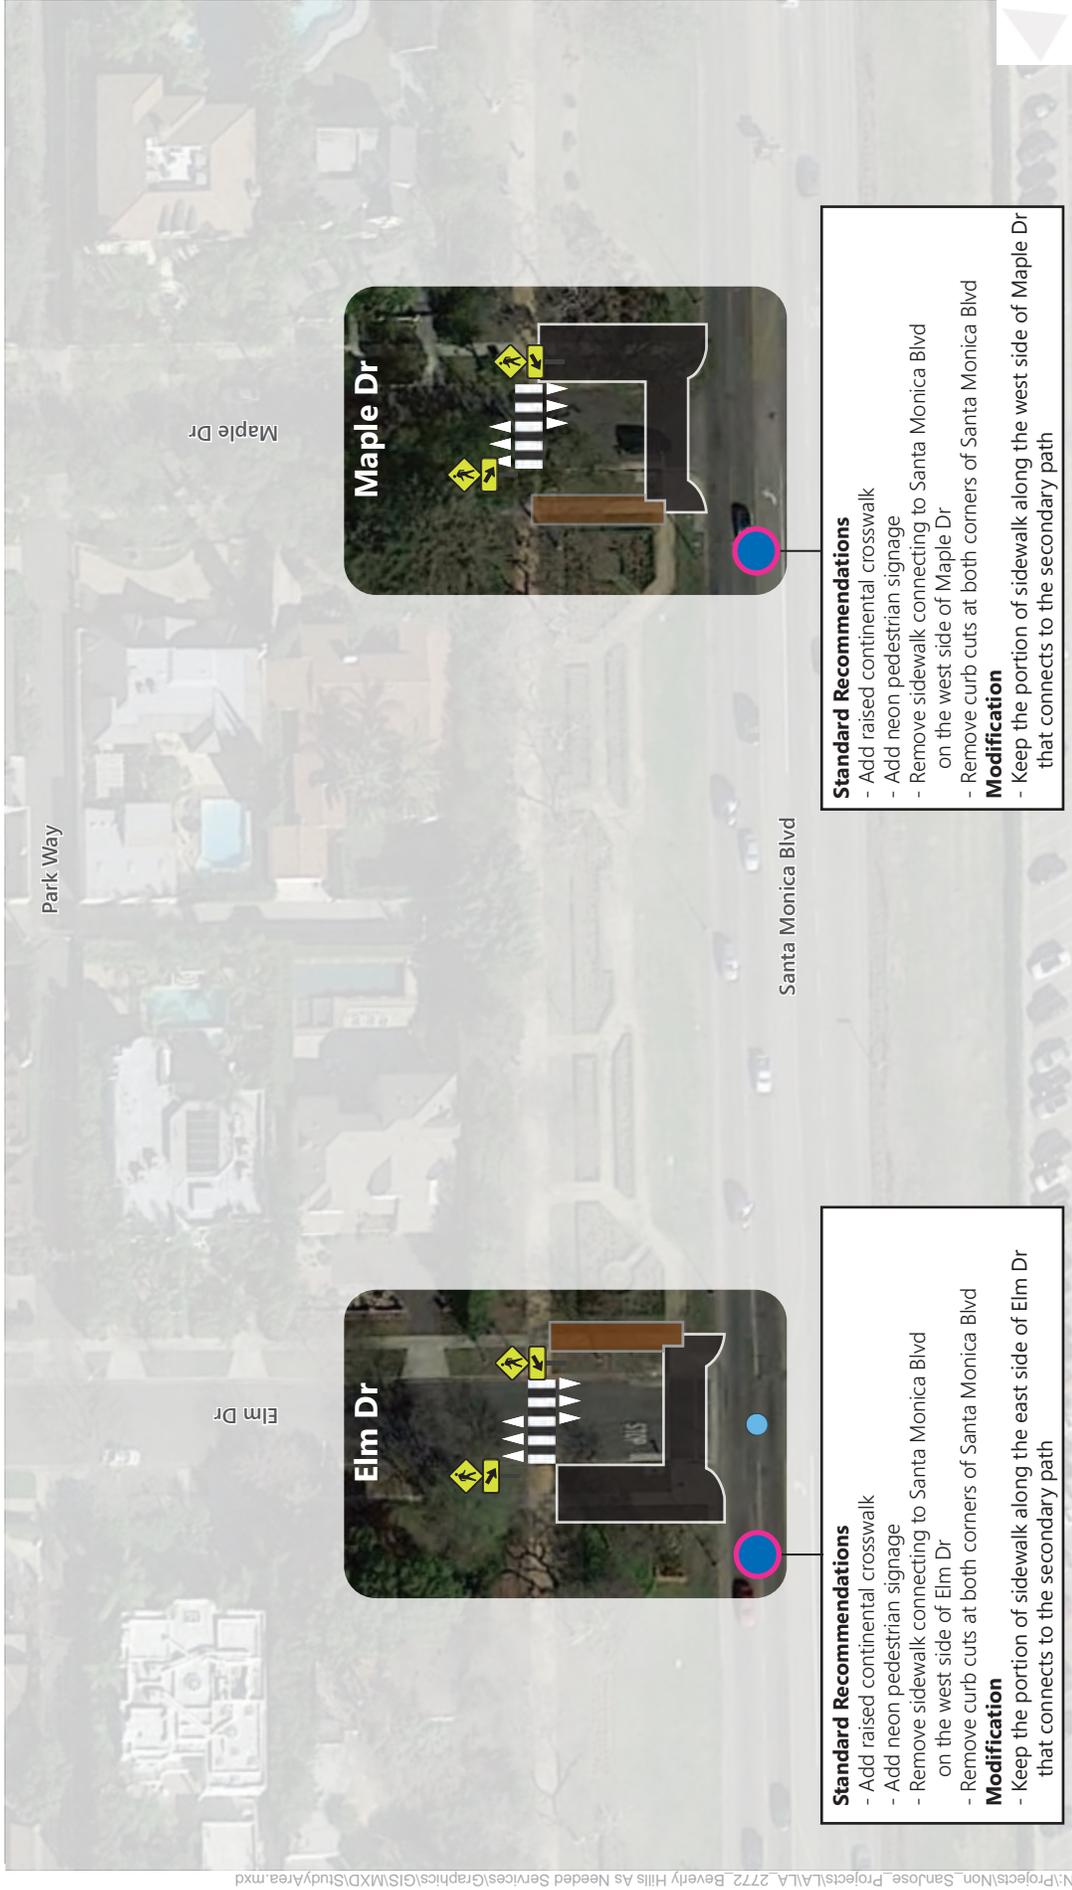
Figure 5  
Elm Drive and Maple Drive

Elm Drive	Santa Monica Boulevard	Standard marked crosswalk at the intersection	Standard recommendations except keep the portion of sidewalk along the east side of Elm Drive that connects to the secondary path (Figure 5)
Maple Drive	Santa Monica Boulevard	No marked crosswalk	Standard recommendations except keep the portion of sidewalk along the west side of Maple Drive that connects to the secondary path (Figure 5)
Hillcrest Road	Santa Monica Boulevard	Standard marked crosswalk at the intersection	Standard recommendations above
Arden Drive	Santa Monica Boulevard	Standard marked crosswalk at the intersection	Standard recommendations above
Alta Drive	Santa Monica Boulevard	Standard marked crosswalk at the intersection	Standard recommendations above
Sierra Drive	Santa Monica Boulevard	No marked crosswalk	Standard recommendations above
Carmelita Avenue	Santa Monica Boulevard	No marked crosswalk	Remove path connection to curb on Carmelita and add a 2-stage continental crosswalk that is not raised (Figure 6)
